# **VIBRATION ANALYSIS CASE HISTORY**

#### **PROBLEM STATEMENT:**

# FEED WATER PUMP HISTORY

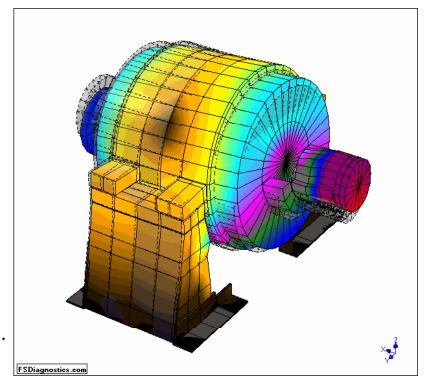
**Current Motion Indicates Vertical Pitching Mode**

EMA defined HORIZONTAL Torsional Mode @ 5,112 RPM [1x]. This Resonance is Resolved by Structural Modification

EMA defined a VERTICAL PITCHING MODE @ 4,200 CPM [>20% Resonance Margin] Recommended Pedestal Structural Modification is NOT expected to alter this mode.

The 2005 Vertical Pitching Mode at 4,200 CPM is suspected to be stiffened into the Operating Speed Range due to Large Piping Line (2014) and/or Foundation Modifications (2012) associated with the shifts in Vertical Overall Vibration response.

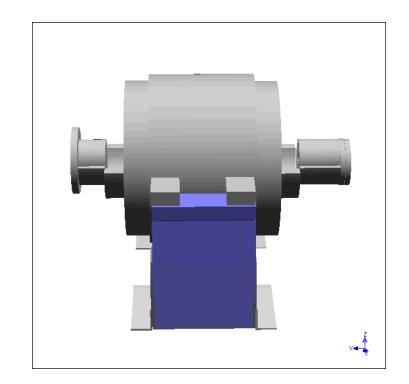
Note that the (Vertical Pitching ) mode at 69.9 Hz was not expected to increase due to the gusset modification, which was designed to restrict only the "torsional" response.

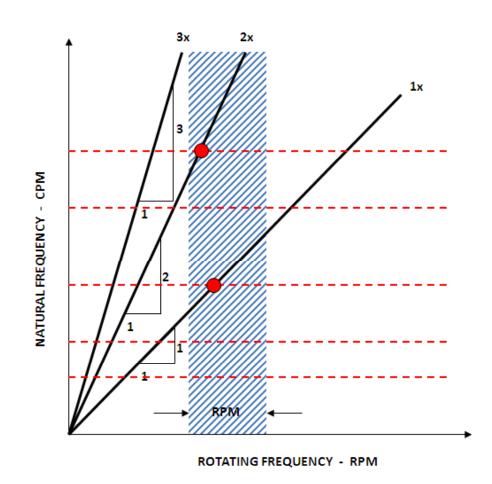
Crossings of the rotating orders (1x, 2x, ...RPM) and the plotted natural frequencies within the operating speed ranges indicate possible resonance concerns that may impact the vibratory amplitudes in the system. Note that mechanical systems are designed with rotating speed margin (difference) on natural frequencies to reduce amplification due to resonance.

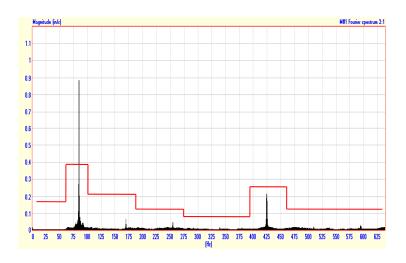
### **Vertical Pitching Mode: 85 Hz**

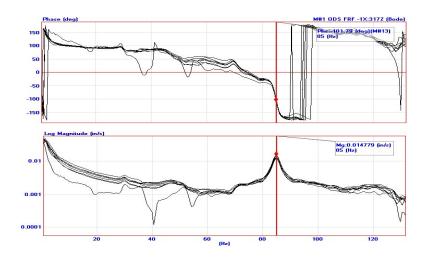
## **Vertical Pitching Mode: 85 Hz**

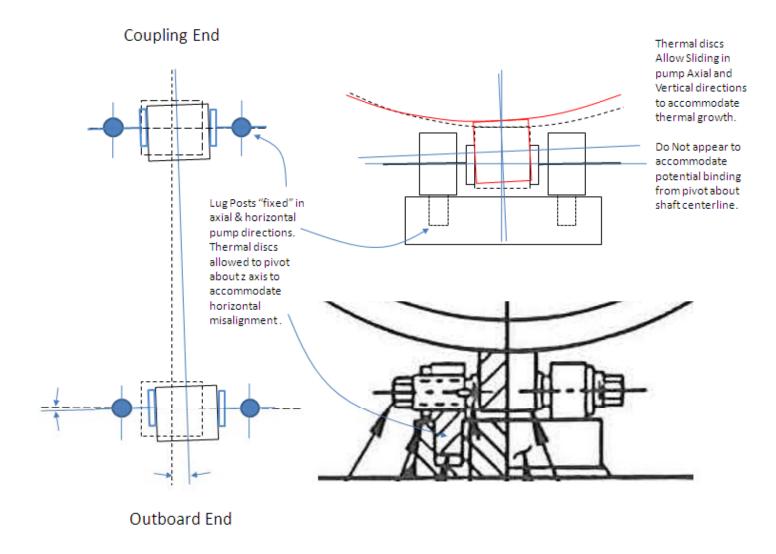
DIGGING DEEPER Searching for the Discrepancies in the Analysis vs. Data Potential External Forces on Pump Piping / Foundation / Alignment Guide Lugs

## Attained Approval to "Un-Lock" the Alignment Guide Barrel Lugs

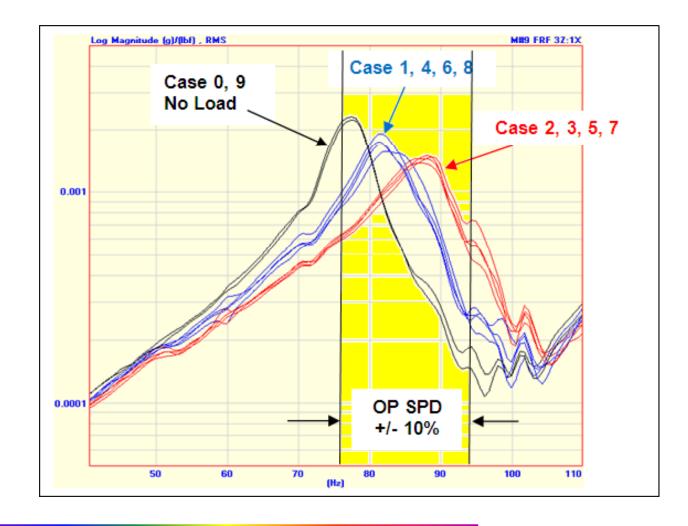
Testing indicated that the VPM<sub>7</sub> natural frequency was potentially "tunable".

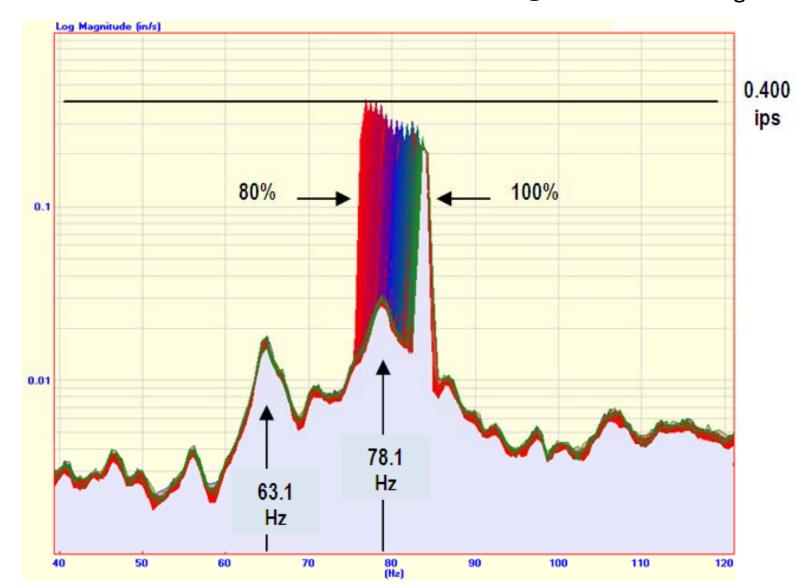
100% Power – Acceptable Response60% Reduction in Vertical Vibration @ Outboard Bearing

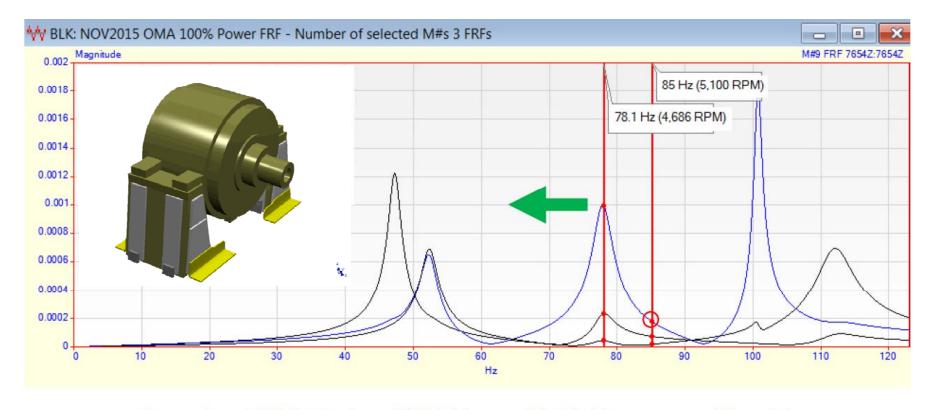
November 2015 Startup 100% Power (8.1% Resonance Margin)

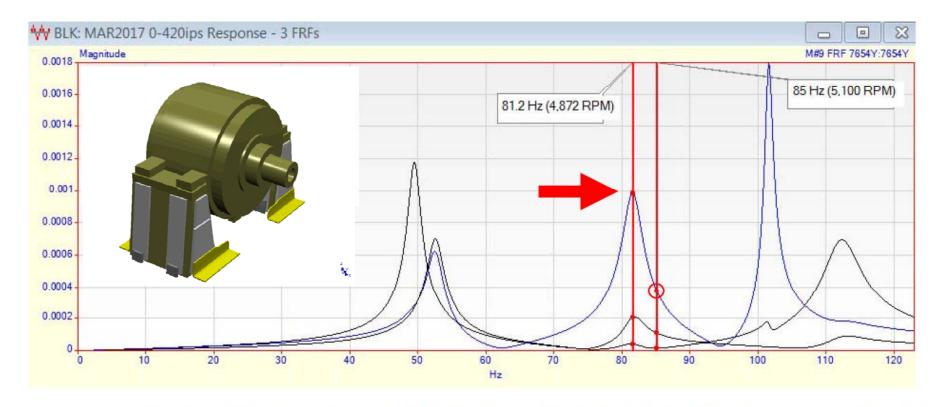
March 2017 Operating @ 100% Power (0.420 ips) (4.5% Resonance Margin)

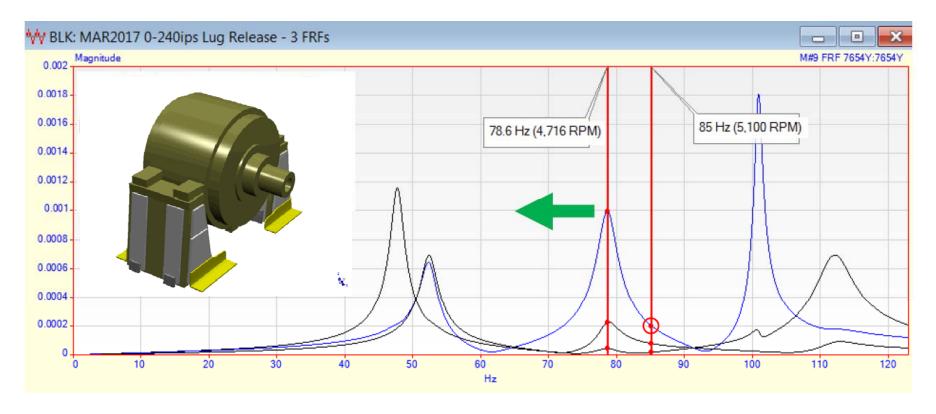
March 2017 100% Pwr Lugs Released (0.240 ips) (7.5% Resonance Margin)
