**POWER HOUSE FD & ID FANS
ANALYZING CONCRETE FOUNDATION RESONANCE**

Ken Singleton

**Bob McGinnis, P.E.
McGinnis Engineering LLC, Kingsport TN**

Abstract: A request was received to investigate high amplitude vibration of forced draft (FD) and induced draft (ID) fans at a coal fired power plant. Operating deflection shape analysis (ODS) and experimental modal analysis (EMA) were specifically requested. Of most concern was reported vibration amplitude over 0.40 in/sec pk on the ID Fan A outboard bearing. Steel bracing had been bolted to the ID Fan's outboard pedestals in an attempt to reduce vibration. In-place balancing had been performed but was not effective in reducing the primarily axial direction vibration. Vibration data on the motor and fan bearing housings was monitored by a System 1 online acquisition system acquiring data from velometers. Proximity probes were not installed at the fluid film bearings.

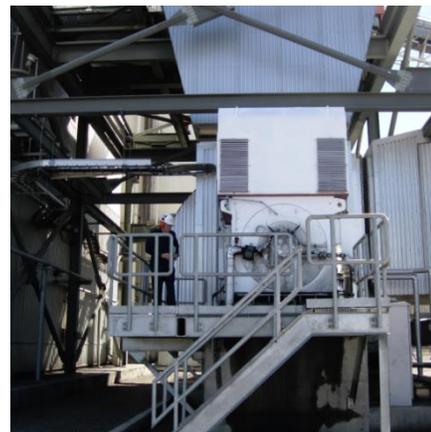
Figure 1. ID Fan A.

Vibration had reportedly exceeded 0.40 in/sec pk. A Steel brace had been installed in an attempt to reduce the bearing housing axial vibration. The brace was fabricated of 8" square tubing and bolted to both ID Fan's outboard pedestals, as shown in **Figures 2 & 3**.

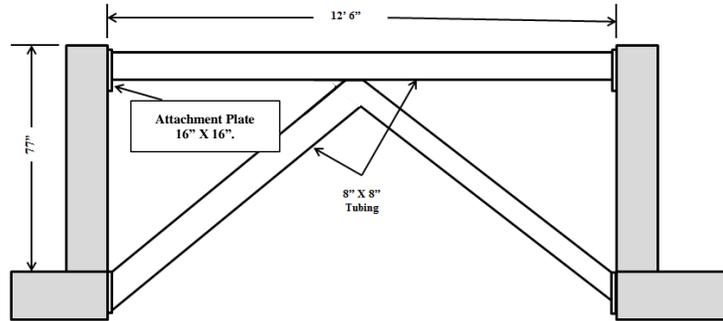
Figure 2. Brace of 8" Square Tubing Bolted to ID Fan Outboard Bearing Concrete Pedestals.

- ID Fans A & B outboard pedestals were connected by a steel brace fabricated of 8" square tubing. Brace steel plates were bolted to the concrete pedestals. These plates had a thickness to width ratio which allowed flexing between the attaching bolts and the 8" square tubing. This was also contributing factor to excessive vibration.

5. Insure that the Dodge Sleeve Bearing plunger bolts are torqued to $3600 \text{ in/lb}_f = 300 \text{ ft/lb}_f$ as stamped on the plunger stud.
 6. Remove the steel bracing connecting the ID Fan A & B outboard pedestals. Replace with individual bracing bolted to massive concrete pad per drawing, see **Figure 40**. Install the pedestal reinforcing plates per **Figure 39**.

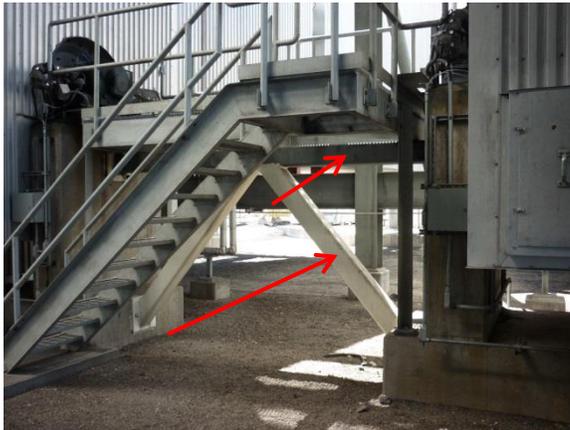
Figure 3. ID Fan A & B, Outboard Pedestals, Steel Bracing Bolted to Each Pedestal.

5. The steel brace between outboard pedestals of ID Fans A & B provided a vibration transmission path. The result was a beat frequency caused by the RPM difference of the two fans at the time of testing 1.97 RPM = 0.0328 Hz = 30.45 Sec. A result of this would be difficulty balancing the fan

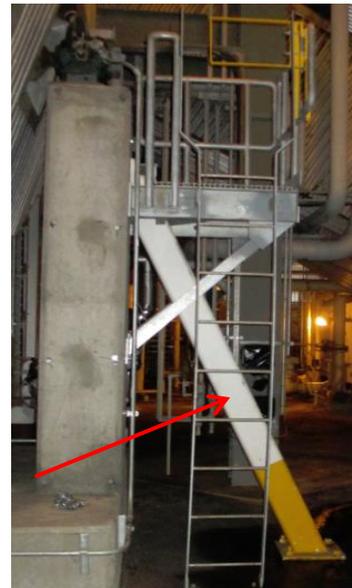
Figure 4: ID Fan A Outboard Bearing Pedestal Single Brace 30 Deg Angle.

- Bracing was also installed on the FD Fan outboard fan pedestals, **Figure 4**. These braces were also fabricated of 8" square tubing and installed at a steep 25 degree angle. Access to the bearings was by ladder. Brace plates were bolted to the concrete pedestal and concrete floor. The brace was not completely effective in reducing vibration to acceptable amplitudes.
- ID fan's concrete foundations had many cracks that appeared to extend deep within the foundations, **Figure 5**. The quality of the concrete appeared substandard.
- ID and FD Fan concrete pedestals did not appear bonded to the concrete foundations although rebar likely extended from the foundations up into the pedestals. Drawings were not available to verify construction details. The joint was cracked at the interface of the pedestals and foundation, shown by photo of ID Fan A outboard pedestal, **Figure 6**.

- FD Fan A & B outboard pedestals were braced in the axial direction at 25 degree angle with fabricated 8" square tubing. Brace steel plates were bolted to the concrete floor and concrete pedestals. High amplitude axial vibration was reported to have occurred although vibration data we measured was low amplitude.

- Consider replacing the bracing of the fan outboard bearing pedestal per **Figure 41**.
- Consider modifying the fan outboard pedestal ladder access with platform and stair access.

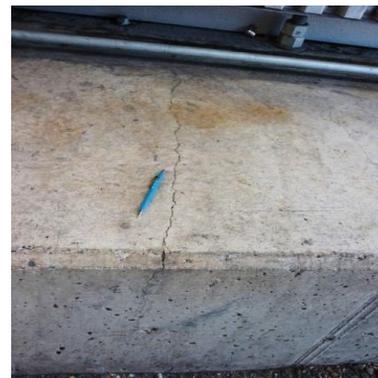
Figure 5. ID Fan A Foundation Crack.

- ID fan concrete foundations had many cracks that appeared to extend deep within the foundations. The quality of the concrete appeared substandard.
 - ID and FD Fan pedestals did not appear bonded to the concrete foundation.

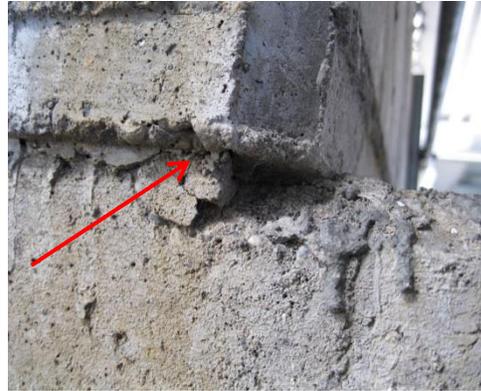
Figure 6. ID Fan A, OB Concrete Pedestal & Foundation Interface.

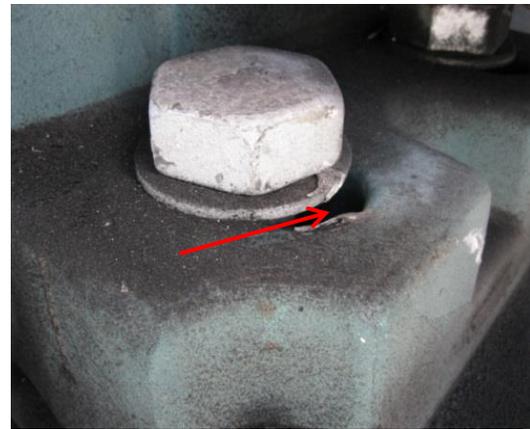
Figure 7. ID Fan A, Inboard Bearing Housing Hold Down Bolt – Washer Was Too Thin.

4. Insure that the fan bearing housing hold down bolts are properly lubricated and correctly torqued. A minimum ½ inch thick washers and Grade 8 bolts should be used. Thread lubricant should be applied to the threads, bolt heads and nut faces.

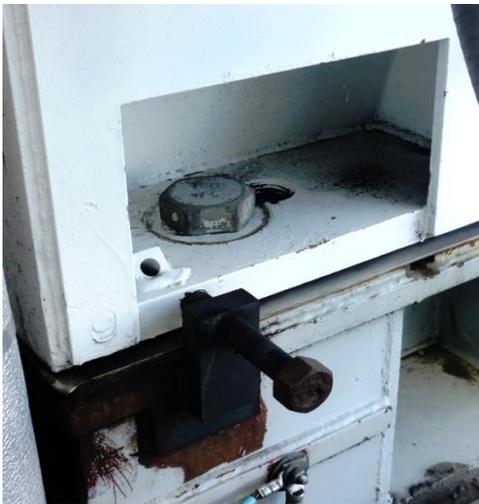
Figure 8. ID Fan A & B Motor Hold Down Bolts Used Tapped Holes in Fabricated Steel Base.

- ID Fan Motors were bolted to a fabricated steel base using tapped holes in 1" thick steel. Through bolting using Grade 8 bolts with thick washers and nuts would have been preferred.

2. Consider modifying the ID Fan's motor hold down bolts to through bolts with washers and nuts. Grade 8 bolts, nuts and washers should be used.
 3. Insure that the fan bearing sole plate anchor bolts are correctly torqued.

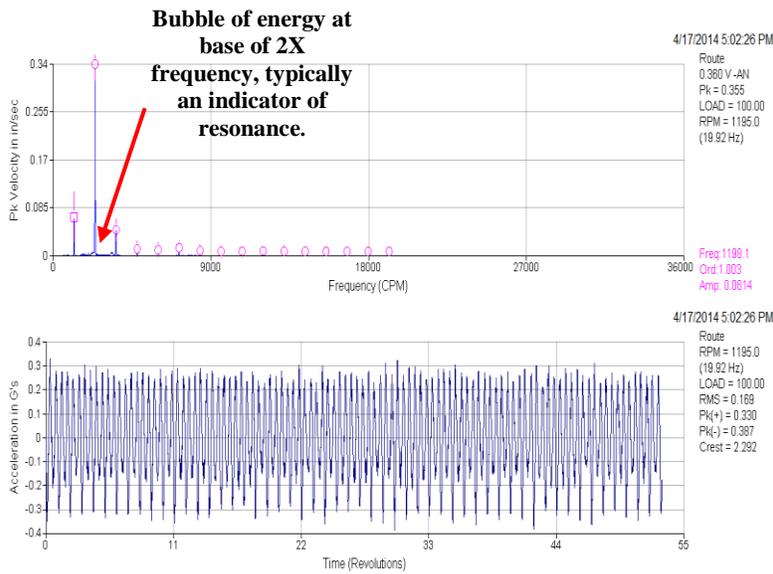
The frequency spectrum and waveform data for ID Fan A outboard bearing housing, axial direction is shown in **Figure 12**. Note the bubble of energy at the base of the 2X frequency which typically is an indicator of resonance. The lower frequency portion of the spectrum plot with log magnitude scaling is shown in **Figure 13**. This plot more clearly shows indication of resonance near the 2X frequency.

Figure 12. ID Fan A, Outboard Bearing, Axial Direction in/sec pk.

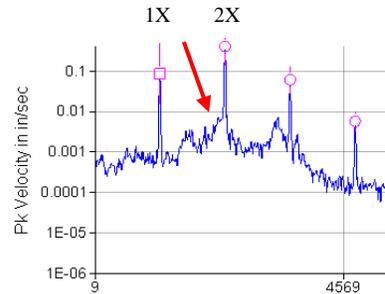
Figure 13. Log Mag Scaling of Lower Frequencies Shows More Clearly Resonance Indication.

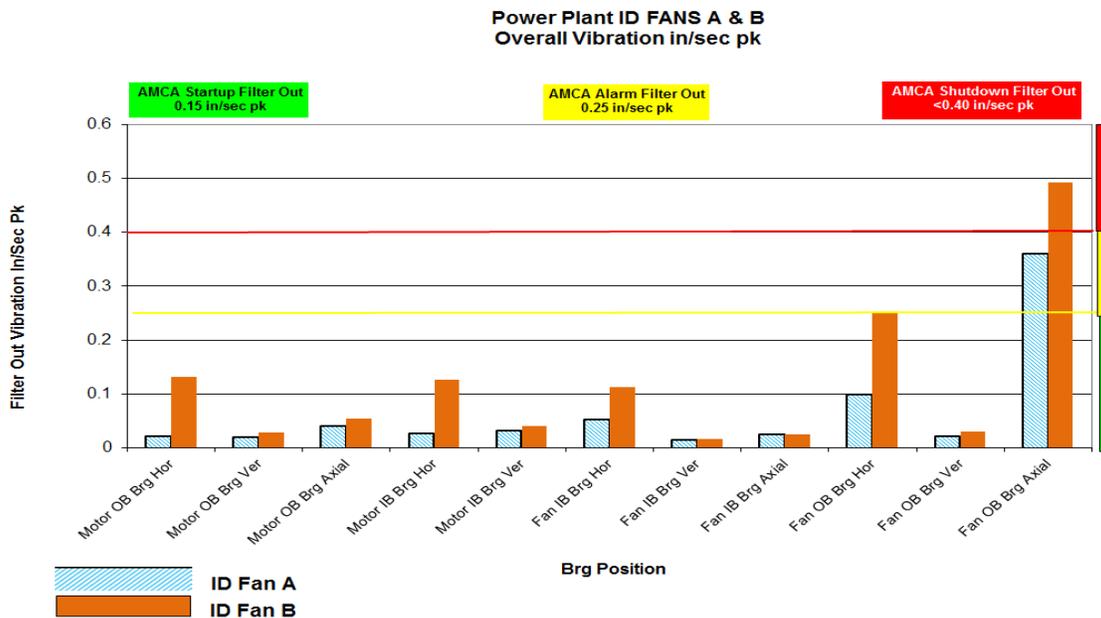
Data showed that ID Fan B, see **Figure 14**, had higher overall amplitude vibration than ID Fan A. The overall vibration amplitudes for the outboard bearing housing horizontal measured 0.252 in/sec pk. Axial vibration at the top of the bearing housing measured 0.492 in/sec pk (well above Shutdown Limit). ID Fan A had lower levels but vibration amplitude of the outboard bearing housing axial direction was at Alarm level.

Figure 14. ID Fan's Overall Vibration in/sec pk.

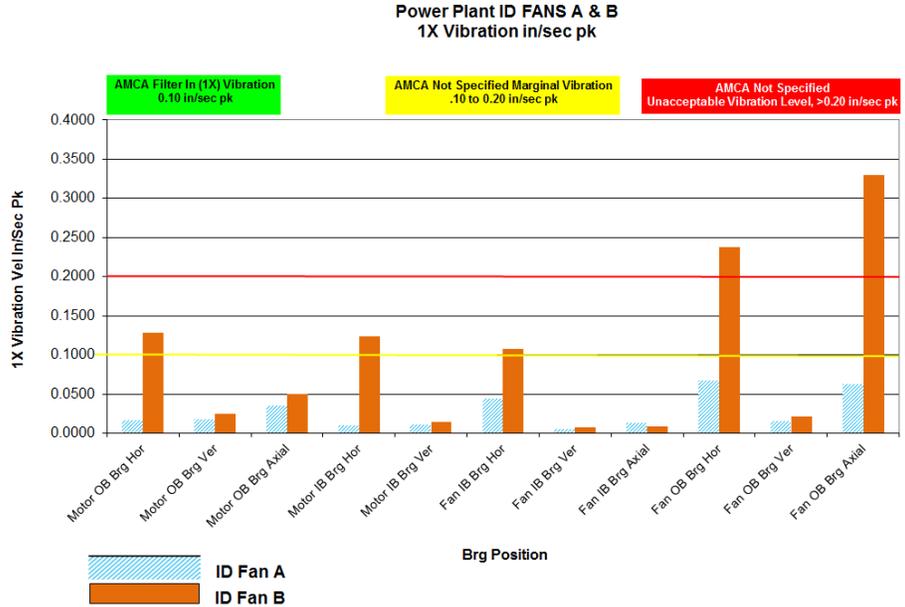
The ID Fan's 1X vibration is shown in **Figure 15**. ID Fan B had much higher amplitude vibration than ID Fan A. ID Fan B outboard fan bearing housing amplitudes were above recommended Shutdown levels and some points were above Alarm Level. Misalignment of the Dodge Sleeveoil bearing to the journal was considered likely as well as amplification of the vibration by structural natural frequencies. Amplitude in the axial direction of ID Fan B outboard bearing housing was 0.333 in/sec pk

Figure 15. ID Fan's A & B Vibration at 1X, in/sec pk.

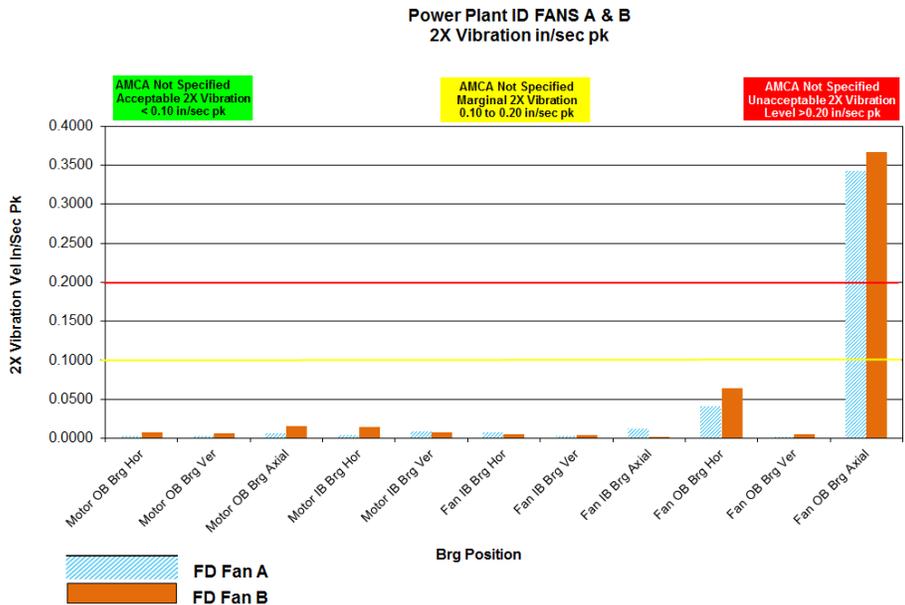
ID Fans A & B vibration measured at 2X is shown in **Figure 16**. Both ID Fan's outboard fan bearing housings had very high amplitude vibration at 2X rotor run speed.

Figure 16. ID Fan's A & B Vibration at 2X, in/sec pk.

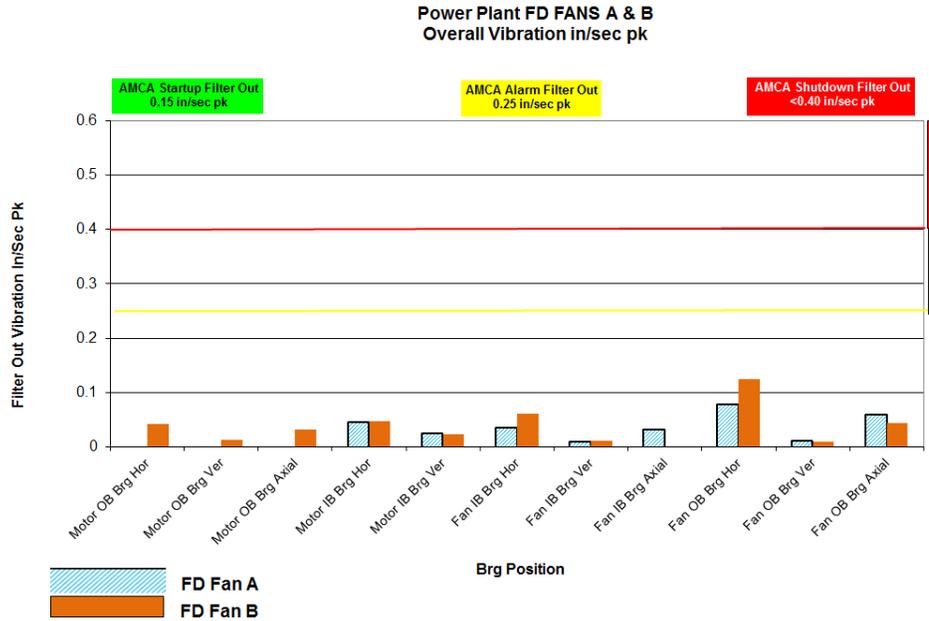
FD Fans A & B overall vibration is shown in **Figure 17**. All points were below AMCA recommended Startup amplitude of 0.15 in/sec pk. The client reported that the FD Fans had experienced high amplitude of vibration in the past.

Figure 17. FD Fan's A & B Overall Vibration in/sec pk.

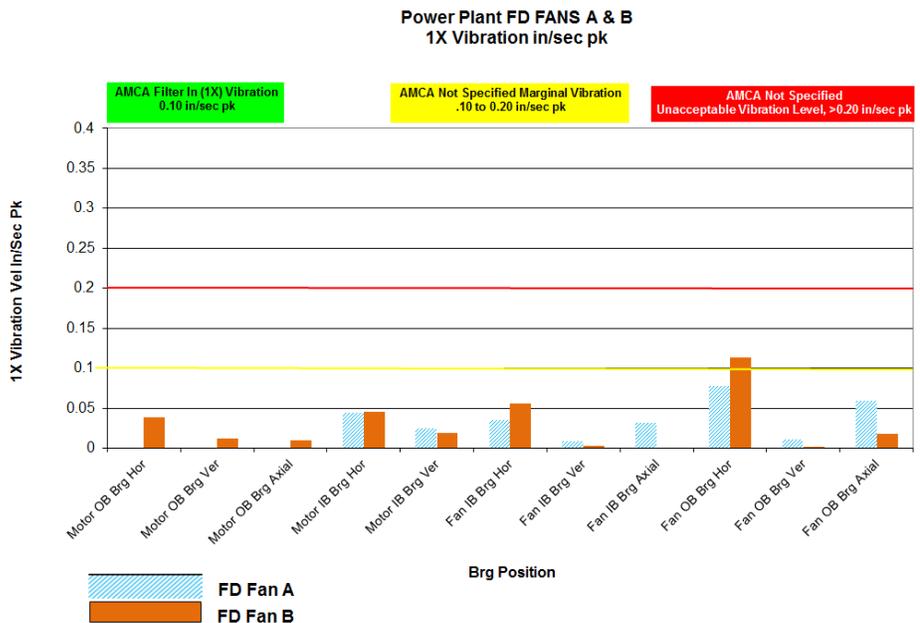
Vibration amplitude at 1X for FD Fans A & B was well below AMCA Startup level with except of one point on FD Fan B, outboard bearing housing horizontal direction, see **Figure 18**.

Figure 18. FD Fan's A & B 1X Vibration in/sec pk.

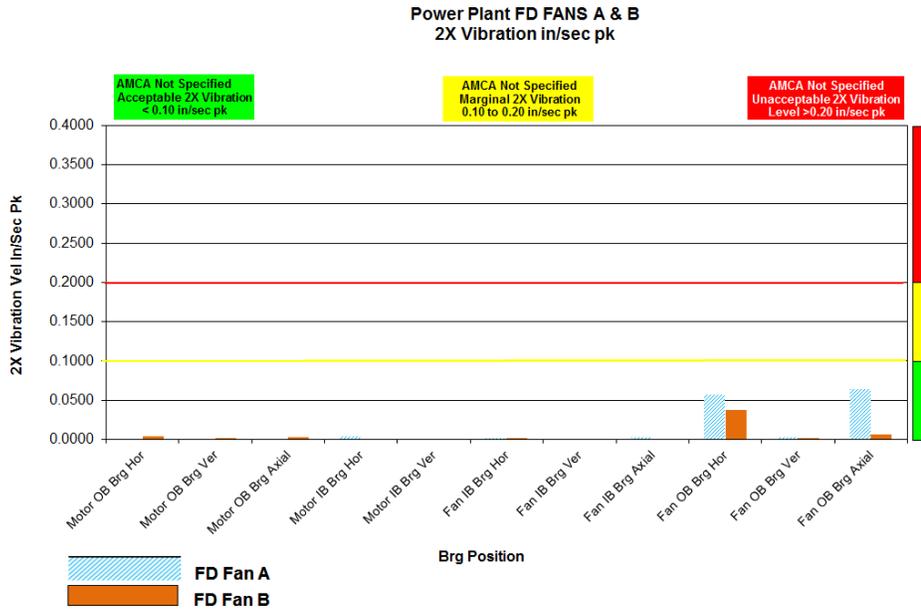
FD Fans A & B vibration at 2X is shown in **Figure 19**. Although AMCA does not specify a vibration tolerance the amplitudes were not considered excessive.

Figure 19. FD Fan A & B Vibration at 2X, in/sec pk.

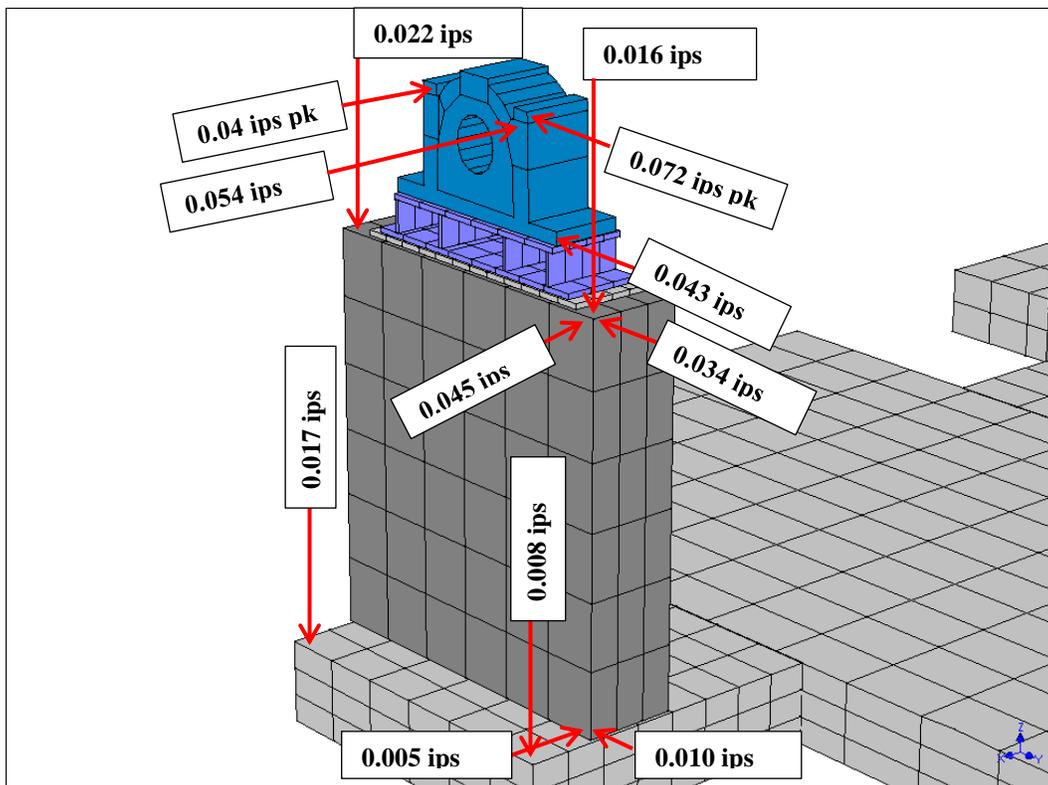
The vibration amplitudes at some DOF for 1X run speed frequency on ID Fan A outboard pedestal are shown in **Figure 24**. The amplitudes were not considered excessive.

Figure 24. ID Fan A OB Pedestal Vibration at 1X Run Speed Frequency.

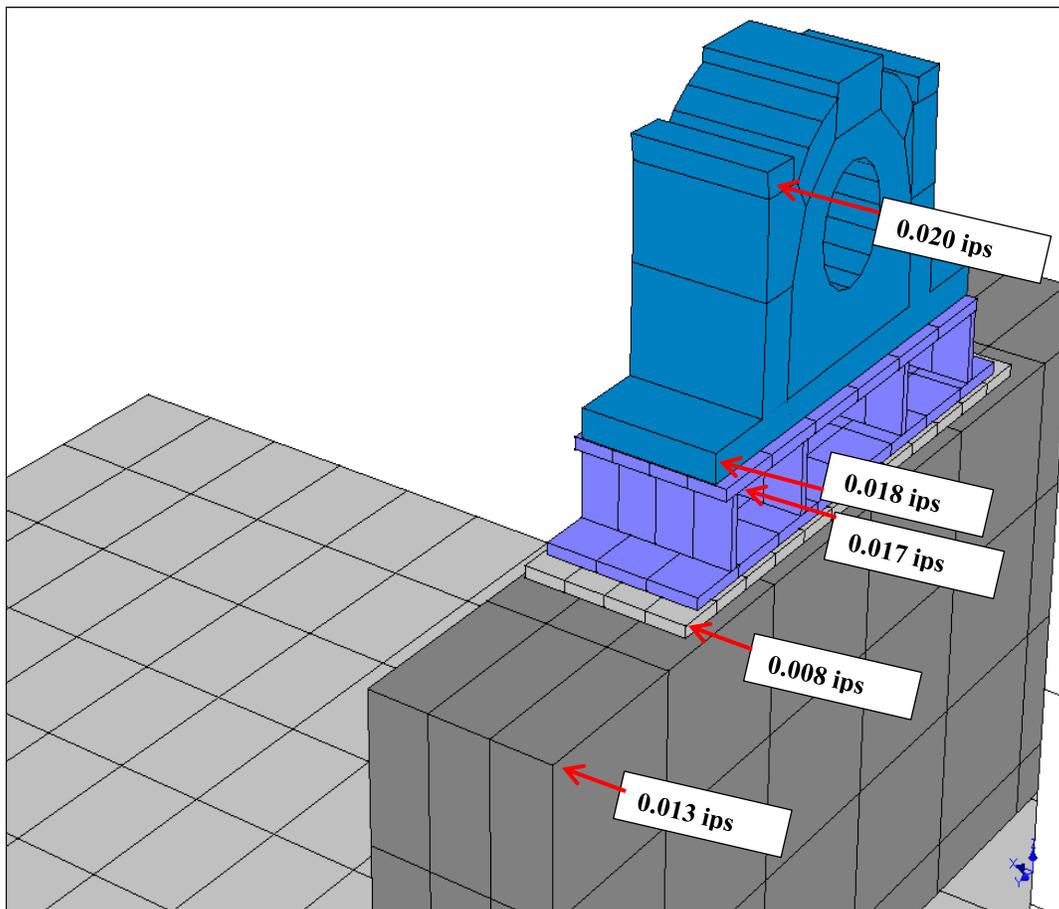
The ODS model of the inboard bearing housing, fabricated base, soleplate and pedestal are shown in **Figure 26**. Some DOF are labeled with vibration amplitude at 1X. Low amplitude slippage of the bearing housing on the fabricated steel base was indicated by the ODS data. However, very little relative vibration of the soleplate to the concrete was indicated.

Figure 26. ID Fan A, IB Brg Housing, Support and Pedestal. ODS Amplitude at 1X Shaft Rotational Frequency.

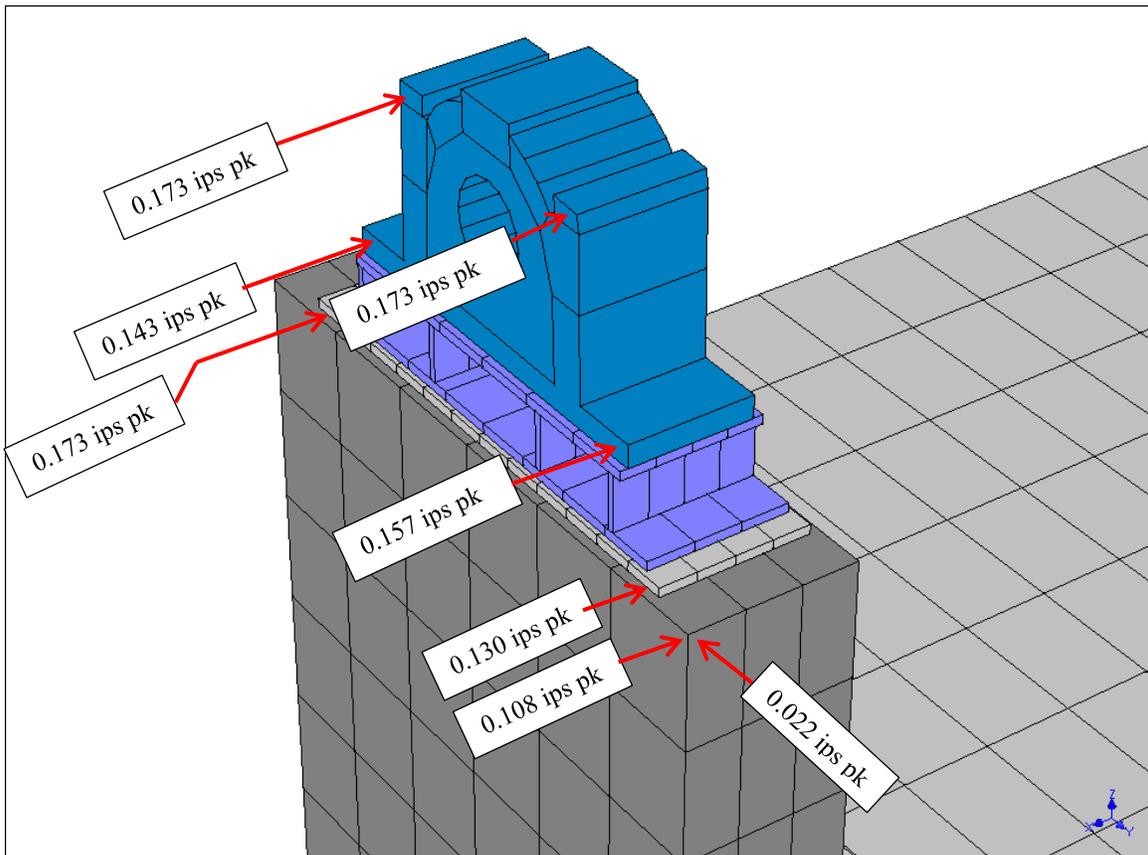
ODS Analysis of Vibration at 2X: ODS data at 2X rotor run speed showed much higher amplitude vibration of the outboard bearing housing and pedestal. The ME'scopeVES model is shown in **Figure 28** with some DOF labeled with vibration amplitudes. Slippage of the soleplate on the concrete pedestal was indicated which could be caused by inadequate tightness of the anchor bolts. Continual slippage would wear the grout.

Figure 28 ID Fan A OB Bearing & Pedestal With Some DOF Vibration Amplitude Labeled at 2X Run Speed.

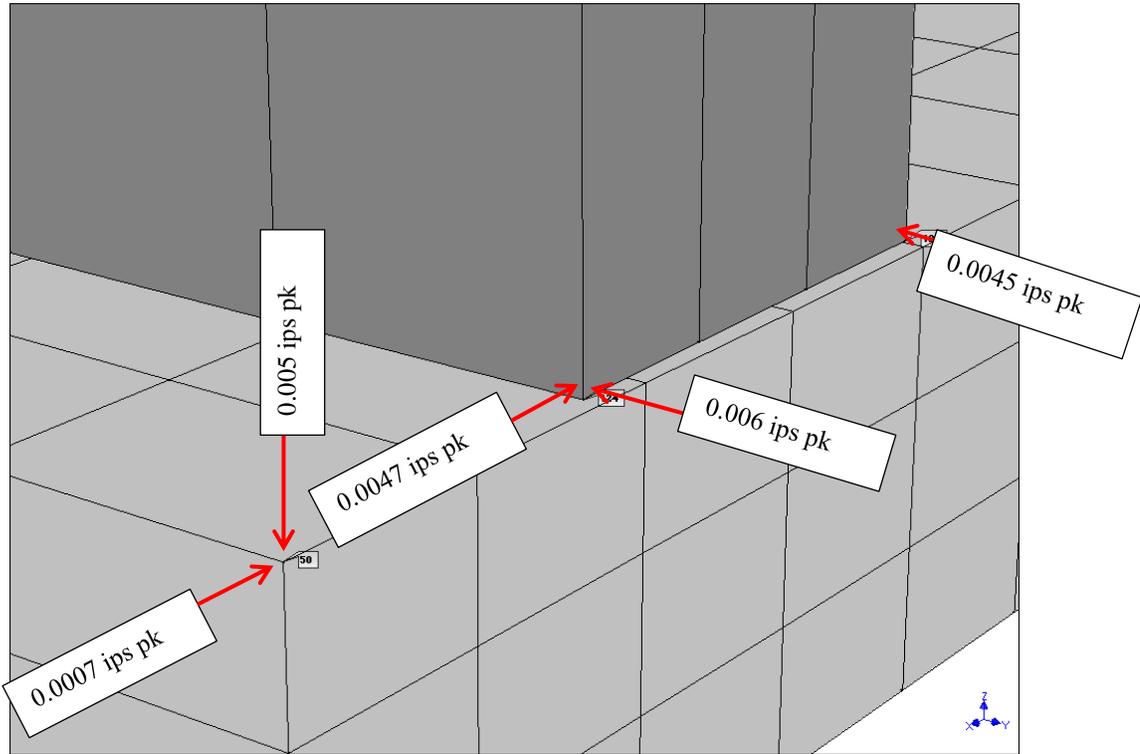
A view of the ODS Model for ID Fan A OB Pedestal to concrete foundation interface is shown in **Figure 29**. The pedestal had a rocking motion. Low amplitude slippage at 2X was indicated by the data although the vibration amplitudes were very low.

Figure 29. ID Fan A, OB Bearing Pedestal Interface to Concrete Foundation.

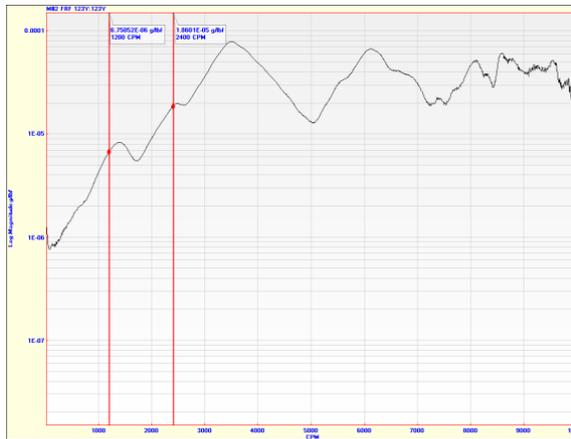
- Natural frequency at 1432.84 CPM with 14.59 % of critical damping.
- Natural frequency at 2508.71 CPM with 3.20 % of critical damping.

Figure 32. ID Fan A Driving Point FRF in Y, 123Y:123Y.

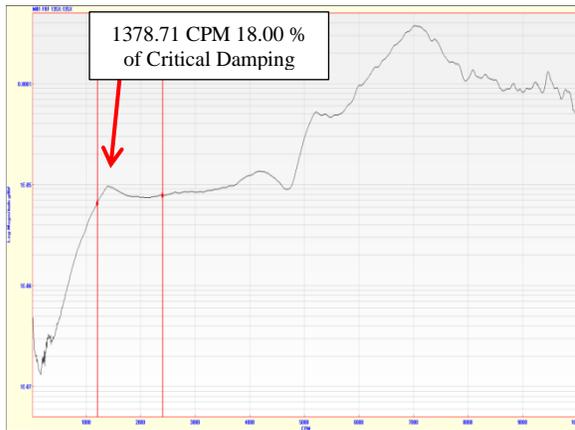
- 1378.71 CPM 18.0 % of Critical Damping (Just above 1X)
- 5107.24 CPM 3.85 % Critical Damping

Figure 33. ID Fan A, OB Pedestal FRF Reference DOF 135X:135X.

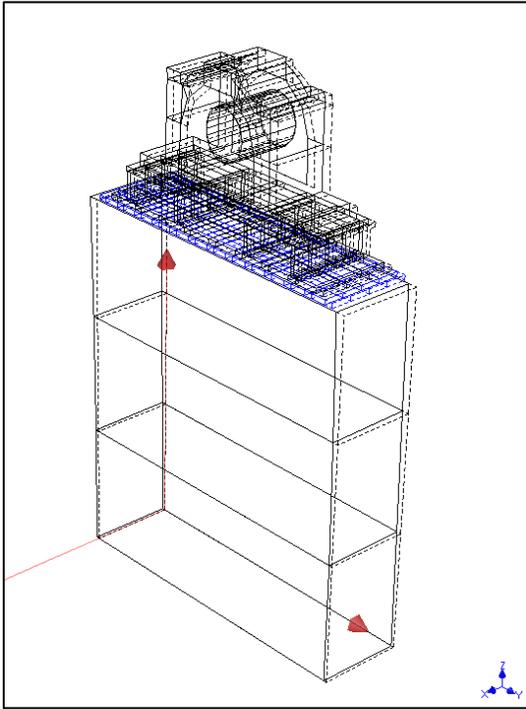
Figure 35. ID Fan A Outboard Bearing Pedestal Modal Test, Mode Shape 1401 CPM Rocking Side-to-Side in Y.

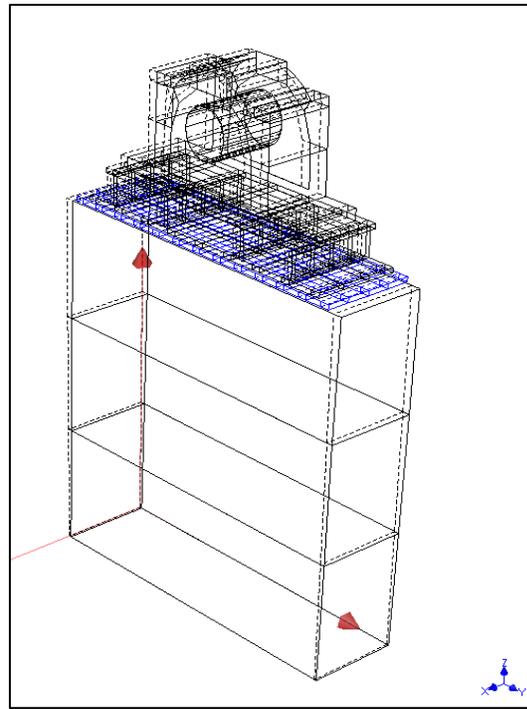
Figure 36. ID Fan A Outboard Bearing Pedestal Modal Test, Mode Shape 2509 CPM Rocking Side-to-Side in Y.

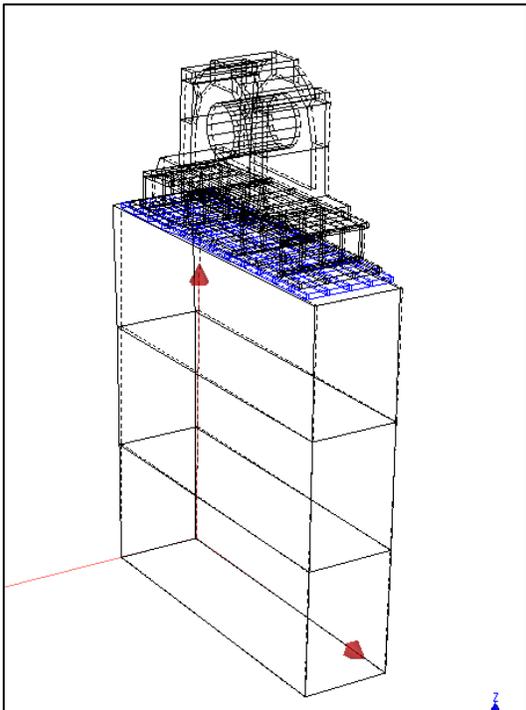
Figure 37. ID Fan A Outboard Bearing Pedestal Modal Test, Mode Shape 1378 CPM Rocking in X (Axial).

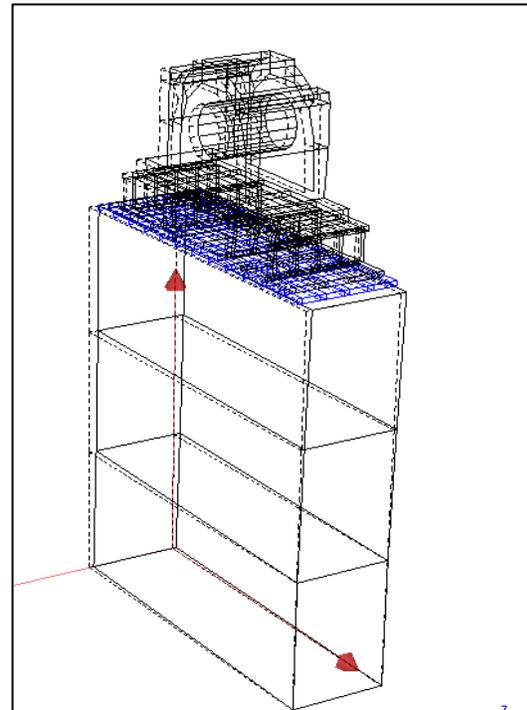
Figure 38. ID Fan A Outboard Bearing Pedestal Modal Test Mode Shape 5107 CPM Rocking in X (Axial).
