Stripped down report example – ODS Section for summary purposes only.

Background

The purpose of the testing was to diagnose the source of high vibration affecting wire connections below the generator on the current transformers (CTs) and Neutral Enclosure.

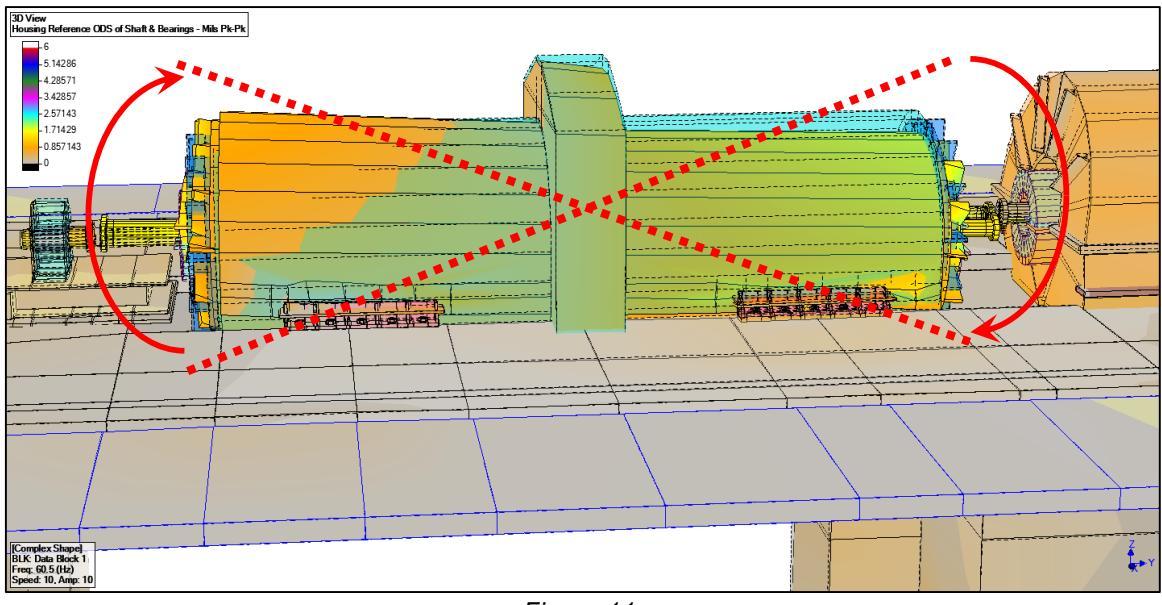
<u>Figure 11</u> XXXXXX TG, 1X ODS Deformation Shape of Generator Vertical Rocking Motion

4.3 The ODS indicates the generator housing is rocking 180 degrees out of phase vertically from end-to-end with displacement of 3.9 mils pk-pk at 1X rotational speed (3600 times per minute). Generator housing vibration does not carry over to the LP-B or exciter stub shaft. The generator housing rocking motion supports a conclusion of shaft misalignment. Figure 11 illustrates the generator housing rocking motion.

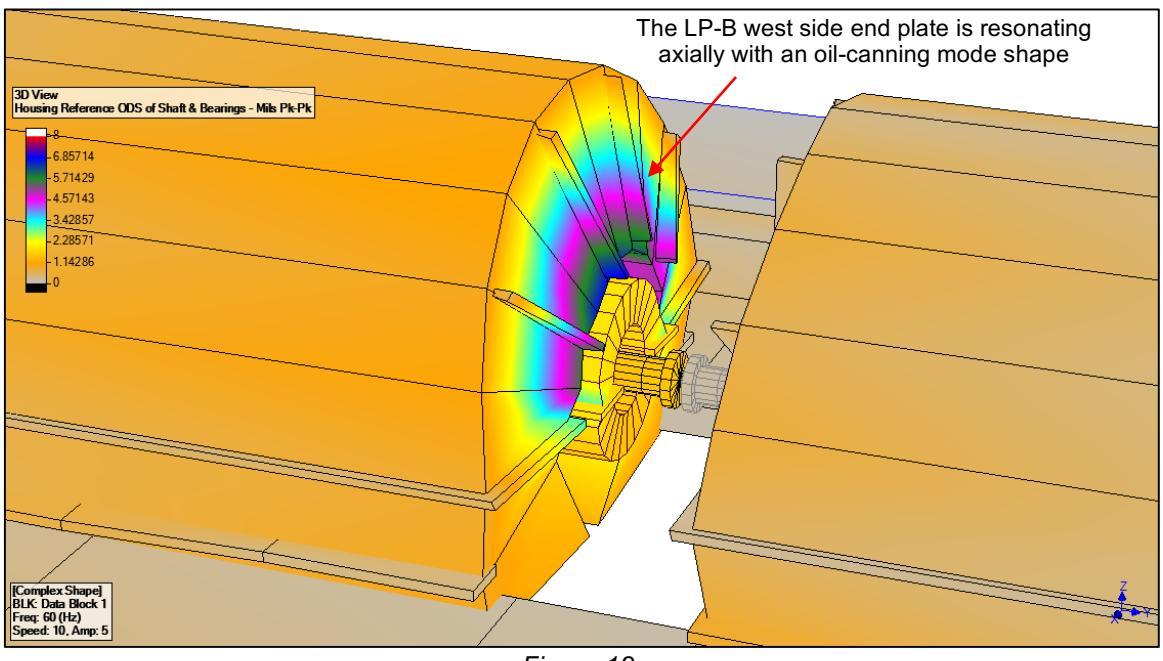
<u>Figure 12</u> XXXXXX TG, 1X ODS Resonance of LP-B Turbine End Plate at Bearing 5

4.4 The end plate on the LP-B turbine at bearing 5 is resonating in the Y direction (axially). The end plate has oil canning mode shape with larger displacement near the center than at the circumference (Figure 12). The maximum end plate displacement is 7 mils pk-pk.

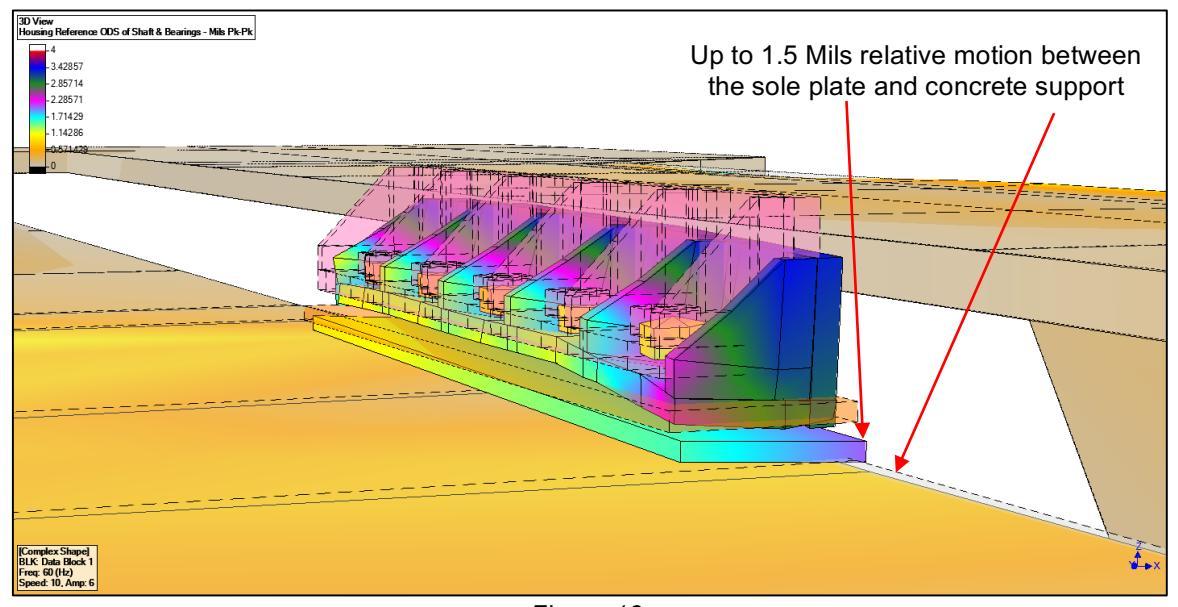
- 4.6 Sole plates, concrete columns and concrete floors supporting the generator are vibrating in response to the generator housing vibration.
 - The two west generator sole plates appear to be loose in the concrete. The ODS identified about 1.5 mils relative vibration between the sole plates and concrete foundation (Figure 13). ODS animation move 8c provides the best view of the sole plate to concrete relative motion. Sole plate looseness may not be an issue if the generator housing vibration is reduced or eliminated.

<u>Figure 13</u> XXXXXX TG, 1X ODS Deformation of West Generator Foot, Soleplate & Concrete Support Looseness between Sole Plate and Concrete Support (dotted line image is the undeformed structure)

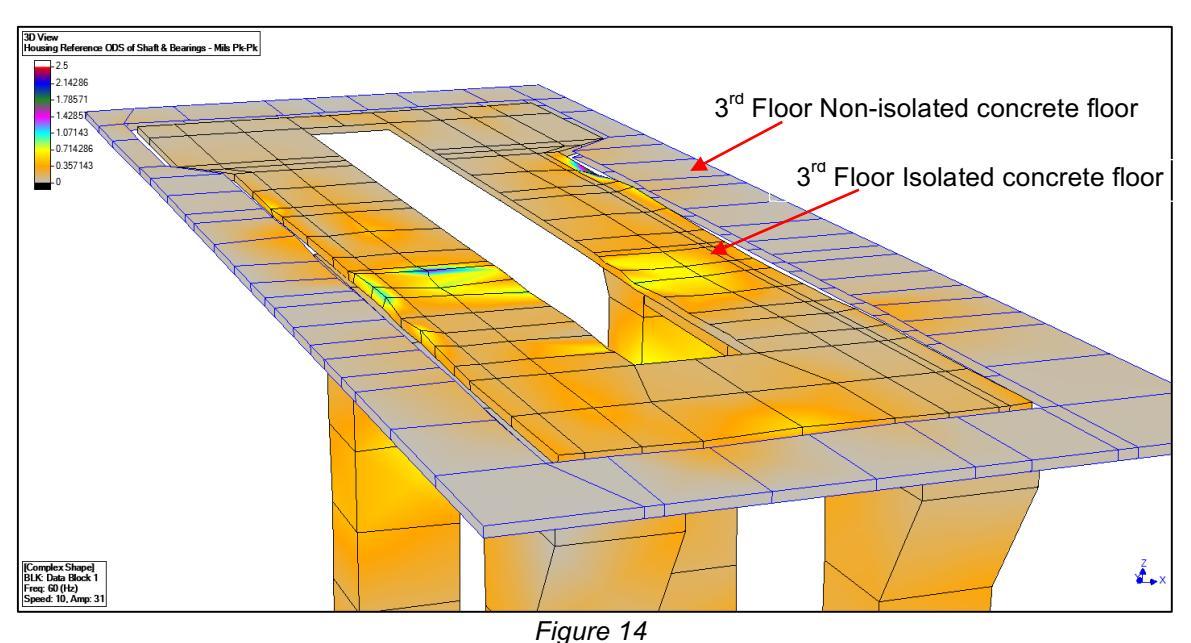
- Vertical vibration on the machine level isolated concrete floor was .10 mils or less at the HP end and .50 mils at the generator end. A few localized sections of the floor were vibrating at higher levels of up to 1.7 mils pk-pk (Figure 14).
- Concrete columns under the generator were vibrating 1.0 mil pk-pk.
- Vertical vibration on the basement isolated concrete floor was up to .42 mils pk-pk on the generator end and much lower on the HP end.

XXXXXX TG, 1X ODS Deformation of Machine Level Isolated and Non-Isolated Concrete Floors

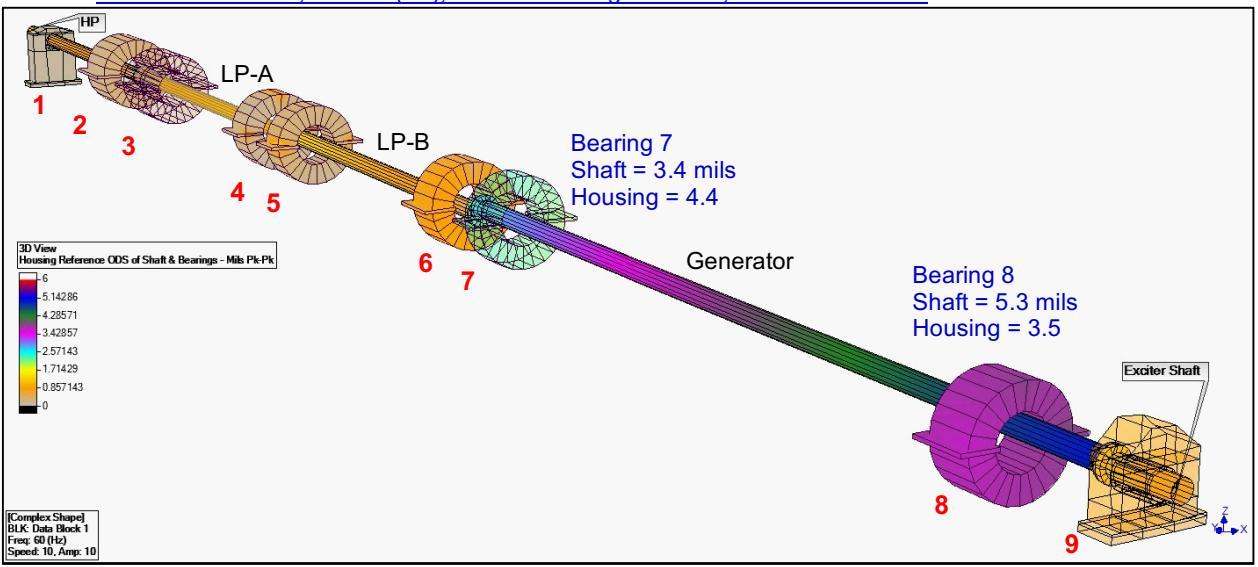
<u>Figure 15</u> XXXXXX TG, 1X ODS Deformation of Shafts and Bearings (all other components are hidden from view)

ODS animations of the shafts and bearings clearly indicate dynamic shaft misalignment. The largest shaft vibration was on the generator (bearings 7 & 8). The most dynamic misalignment was observed on couplings C and D (both ends of the generator shaft).

- The ODS shows the generator shaft vibrating out of phase from end-to-end. Generator shaft vibration lifts the generator bearings and housing (Figure 15).
- Generator shaft vibration was 3.4 mils pk-pk at bearing 7 and 5.3 mils pk-pk at bearing 8.
- Generator housing vibration was 4.4 mils at bearing 7 and 3.5 mils at brg. 8.
- Exciter stub shaft vibration was 1.4 mils pk-pk at bearing 9
- Vibration on the LP-B shaft was .58 mils pk-pk at bearing 6.
- 2X shaft vibration was less than 1.0 mil pk-pk on the generator shafts, 0.4 or less on the exciter stub shaft and much lower on the turbines.

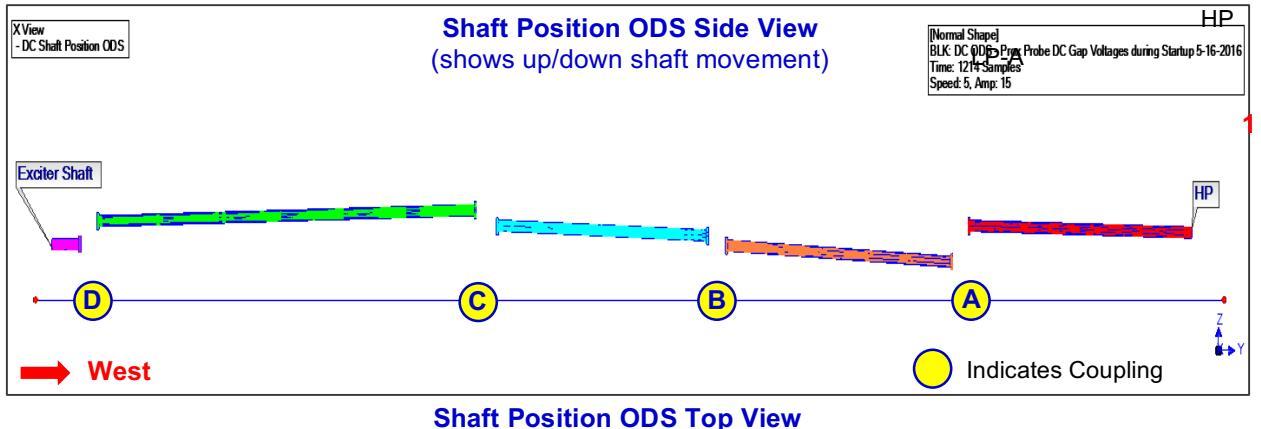
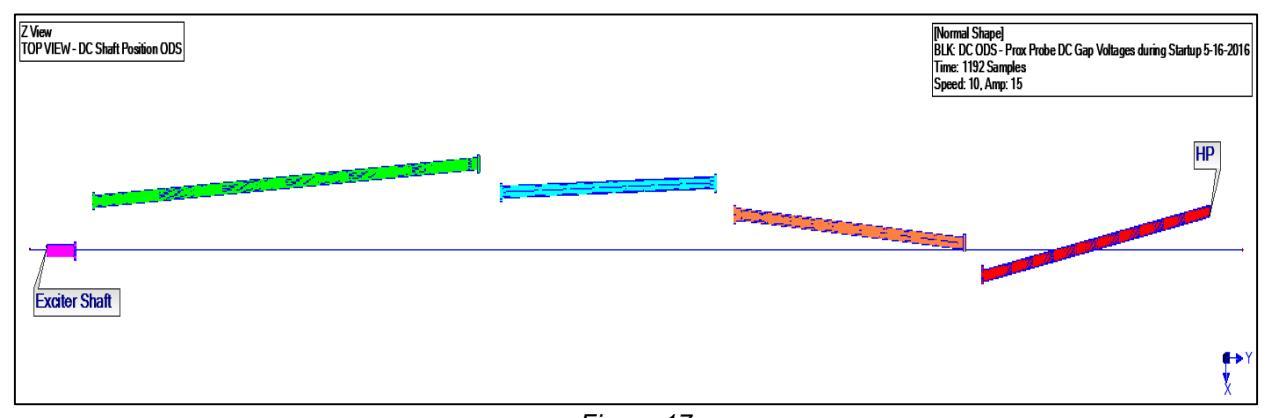
<u>Figure 17</u> XXXXXX TG, DC Shaft Position ODS Picture illustrates shaft movement after reaching full speed and load Up/down view (top plot), N/S view (bottom plot)

• <u>Up/Down Shaft Movement</u> – Immediately after startup, all shafts move upwards towards the X direction radial Proximity Probes (Figure 17 - top).

The generator shaft moved upwards more than the other shafts. It moved 15 mils (3.0 VDC) towards probe 7X and 11 mils (2.2 VDC) towards probe 8X.

LP-B shaft moved upwards 11 mils (2.3 VDC) towards probes 5X and 6X.

Shaft movement was less towards the Y direction Proximity Probes except at bearing 2 where the shaft moved about 9 mils (1.8 VDC) towards probe 2Y.

The exciter stub shaft moved upwards less than all other shafts.

• <u>North/South Shaft Movement</u> – Immediately after startup, all shafts move south except for the exciter stub shaft and the HP shaft at bearing 2.

As the unit reaches full speed and load is applied, shaft parallel and angular offset increases (Figure 17 - bottom).

After reaching full speed, the shaft at HP bearing 2 continues to move north increasing parallel and angular offset at coupling A.

The LP-A shaft at bearing 3 hardly moves at all in the north/south direction.

The shaft position ODSs suggests dynamic shaft misalignment across the machine train.
