# **VIBRATION ANALYSIS CASE HISTORY**

#### **PROBLEM STATEMENT:**

# FEED WATER PUMP HISTORY

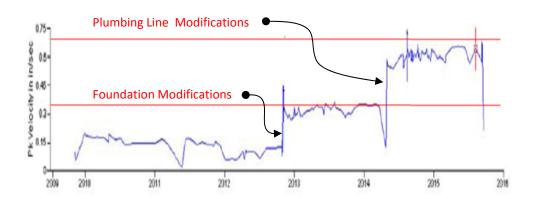
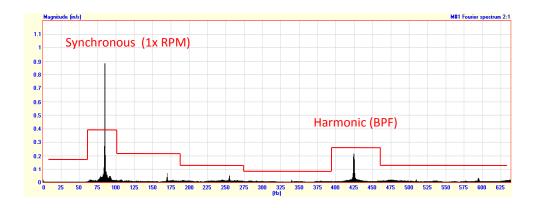
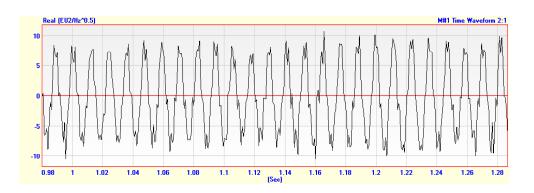
#### **TIME WAVEFORM RESPONSE:**

The Time Waveform shows a dominant synchronous response with a slight higher frequency distortion due to the 5x RPM blade passing frequency.

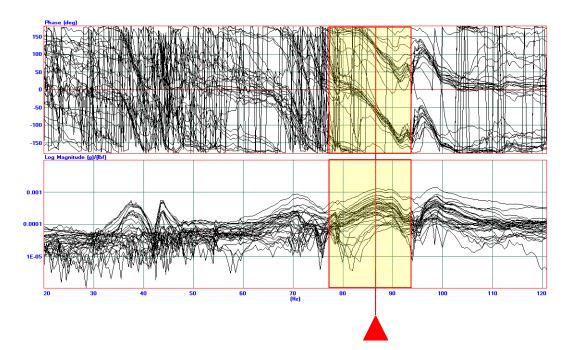
# 2005 EMA Analysis

- 1 37.7 Hz Rigid Body (y)
- 2 43.7 Hz Rigid Body (x, y)
- 3 69.9 Hz Vert Pitch (z)
- 4 85.2 Hz Torsion (z)
- 5 98.3 Hz Torsion (y, z)

The 2005 Vibration Analysis included an Experimental Modal Analysis with the FWP32B in a non-operating condition. The analysis defined several natural frequencies in the system.

A Torsional Mode of the pump was detected within 1% of the normal operating speed @ 85 Hz (5,100 RPM). Excitation of this mode by residual unbalance and alignment forces created an elevated response in the horizontal direction.

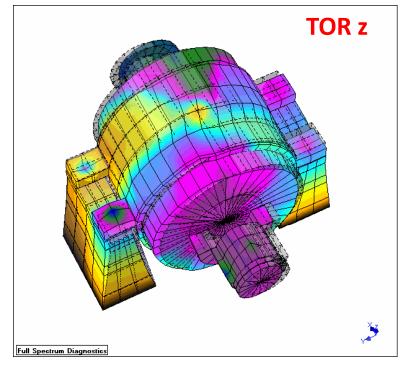
The response could be detected at each bearing but was dominant at the pump outboard bearing. The Overlaid Measurement data set below shows a Magnitude Response and Phase Angle Response (Bode Plot).

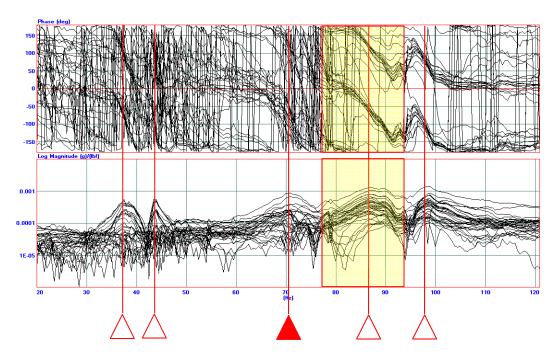
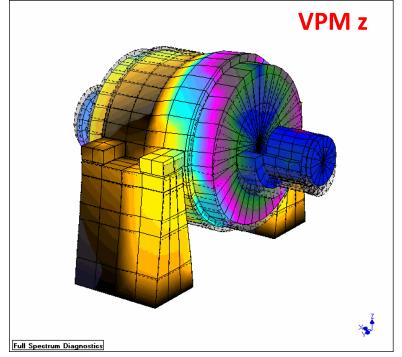
The 2005 Vertical Pitching Mode at 4,200 CPM is suspected to be stiffened into the Operating Speed Range due to Large Piping Line (2014) and/or Foundation Modifications (2012) associated with the shifts in Vertical Overall Vibration response.

- 1 37.7 Hz Rigid Body (y)
- 2 43.7 Hz Rigid Body (x, y)
- **3** 69.9 Hz Vert Pitch (z)
- 4 85.2 Hz Torsion (z)
- 5 98.3 Hz Torsion (y, z)

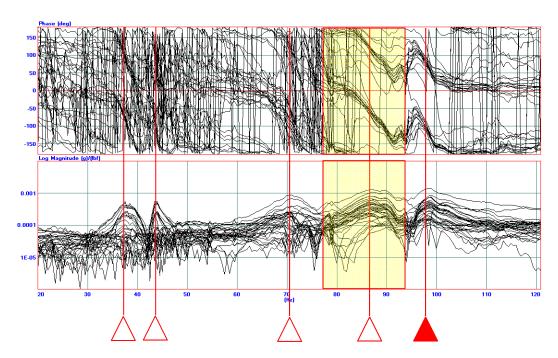
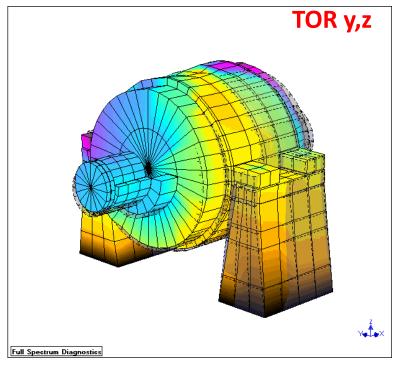
- 1 37.7 Hz Rigid Body (y)
- 2 43.7 Hz Rigid Body (x, y)
- 3 69.9 Hz Vert Pitch (z)
- 4 85.2 Hz Torsion (z)
- 5 98.3 Hz Torsion (y, z)

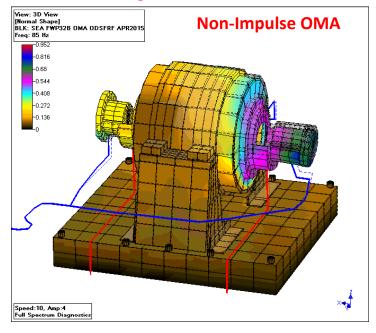
### **Vertical Pitching Mode: 85 Hz**

The operating characteristics of the Feed Water Pump include a sufficient level of "random" background response from turbulent steam flow and rotor energy. If this low-level background noise is processed with significant averaging, the Modal Frequencies and Mode Shapes can be extracted from the final data. This OMA is referred to here as a "Non-Impulse Operating Modal Analysis."

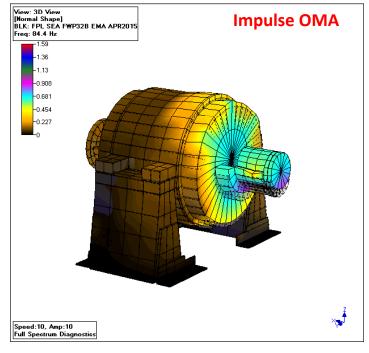
## **Vertical Pitching Mode: 85 Hz**

The 2015 Vibration Analysis also included an Experimental Modal Analysis Impact Test with the FWP32B in an operating condition. This analysis is sometimes called an Operating Modal Analysis. Here it is referred to as an "Impulse Operating Modal Analysis."

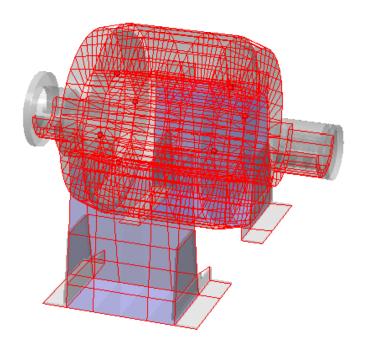
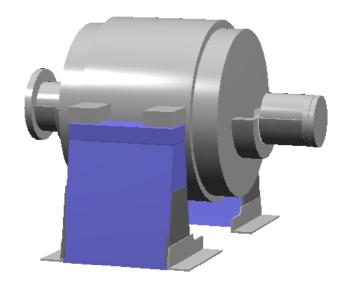
Excellent Correlation with 2005 EMA analysis and Modified Pedestal Gussets introduced into the FEA model.

Except FEA model did NOT Predict the Vertical Pitching Mode to move into the operating speed range.

Use FEA Model to **DEFINE** Structural Modifications to Eliminate or Reduce 1x RPM Vibration Response: Stiffness / Mass / Damping / Phase Cancellation

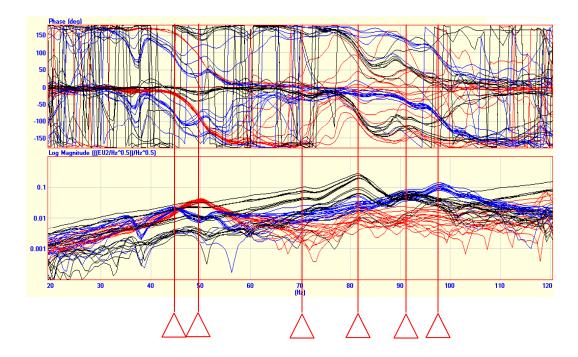
# 2015 EMA Analysis Pre-Modifications

- 1 47.4 Hz Lateral RBM
- 2 51.2 Hz Axial RBM
- 3 72.9 Hz Vertical RBM
- 4 83.7 Hz Vert Pitch Mode
- 5 97.0 Hz Torsional Mode
- 6 100 Hz Torsional Mode

Mode	Mode Shape	2015 EMA(1) [@ SD (hot)]	2015 EMA <sup>(2)</sup> [@ SD (cold)]	2015 EMA BL <sup>(3)</sup> [@SD Dewater]
1	Lateral RBM* (y)	46.0 Hz	46.7 Hz	47.4 Hz
2	Axial RBM* (x)	49.8 Hz	49.6 Hz	51.2 Hz
3	Vertical RBM* (z)	71.5 Hz	71.4 Hz	72.9 Hz
4	Vertical Pitch (z)	81.7 Hz	81.7 Hz	83.7 Hz
5	Torsion (z)	91.4 Hz	90.6 Hz	97.0 Hz
6	Torsion (y, z)	97.0 Hz	97.5 Hz	100 Hz

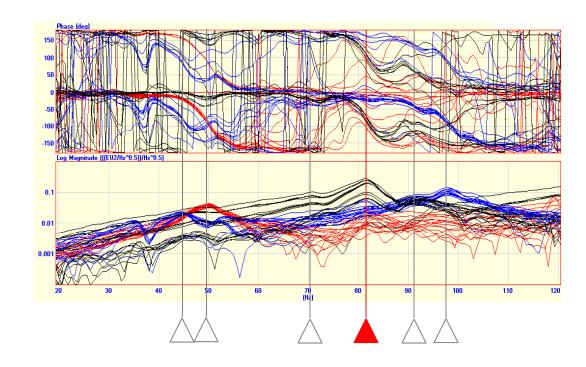
# 2015 EMA Analysis Post Plating Modifications

- 1 49.1 Hz
- 2 52.1 Hz
- 3 74.5 Hz
- 4 86.9 Hz [Plating Δ 3.2 Hz]
- 5 97.4 Hz
- 6 104 Hz

Mode	Mode Shape	SDM Plating <sup>(3)</sup> [EMA BL Projected]	2015 EMA <sup>(4)</sup> [Final Plating]
1	Lateral RBM* (y)	58.9 Hz	49.1 Hz
2	Axial RBM* (x)	74.8 Hz	52.1 Hz
3	Vertical RBM* (z)	75.3 Hz	74.5 Hz
4	Vertical Pitch (z)	96.8 Hz	86.9 Hz
5	Torsion (z)	92.3 Hz	97.4 Hz
6	Torsion (y, z)	113 Hz	104 Hz

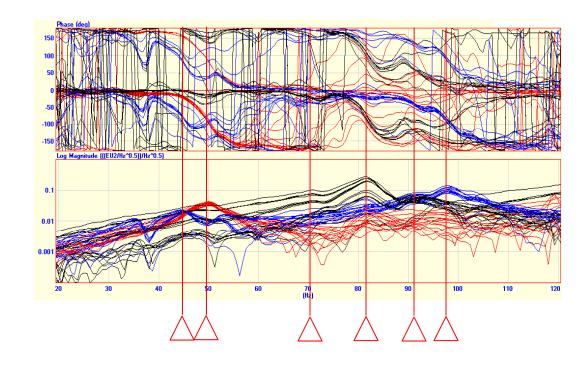
- 1 44.1 Hz
- 2 50.6 Hz
- 3 70.6 Hz
- 4 76.8 Hz [Δf: -11.6%]
- 5 102 Hz
- 6 109 Hz

Mode	Mode Shape	SDM Plating <sup>(3)</sup> [EMA BL Projected]	2015 EMA <sup>(4)</sup> [Final Plating]	2015 EMA <sup>(5)</sup> [Lugs Released]
1	Lateral RBM* (y)	58.9 Hz	49.1 Hz	44.1 Hz
2	Axial RBM* (x)	74.8 Hz	52.1 Hz	50.6 Hz
3	Vertical RBM* (z)	75.3 Hz	74.5 Hz	70.6 Hz
4	Vertical Pitch (z)	96.8 Hz	86.9 Hz	76.8 Hz
5	Torsion (z)	92.3 Hz	97.4 Hz	102 Hz
6	Torsion (y, z)	113 Hz	104 Hz	109 Hz

- (3) SDM Plating Projection based on Baseline EMA analysis [Cold, Uncoupled, Dewatered
- (4) EMA Test Final Plating Complete Oct 16, 2015
- (5) EMA Test Final Plating Complete, Alignment Guide Lugs Released Oct 18, 2015.
