**POWER HOUSE FD & ID FANS
ANALYZING CONCRETE FOUNDATION RESONANCE**

Ken Singleton

**Bob McGinnis, P.E.
McGinnis Engineering LLC, Kingsport TN**

Abstract: A request was received to investigate high amplitude vibration of forced draft (FD) and induced draft (ID) fans at a coal fired power plant. Operating deflection shape analysis (ODS) and experimental modal analysis (EMA) were specifically requested. Of most concern was reported vibration amplitude over 0.40 in/sec pk on the ID Fan A outboard bearing. Steel bracing had been bolted to the ID Fan's outboard pedestals in an attempt to reduce vibration. In-place balancing had been performed but was not effective in reducing the primarily axial direction vibration. Vibration data on the motor and fan bearing housings was monitored by a System 1 online acquisition system acquiring data from velometers. Proximity probes were not installed at the fluid film bearings.

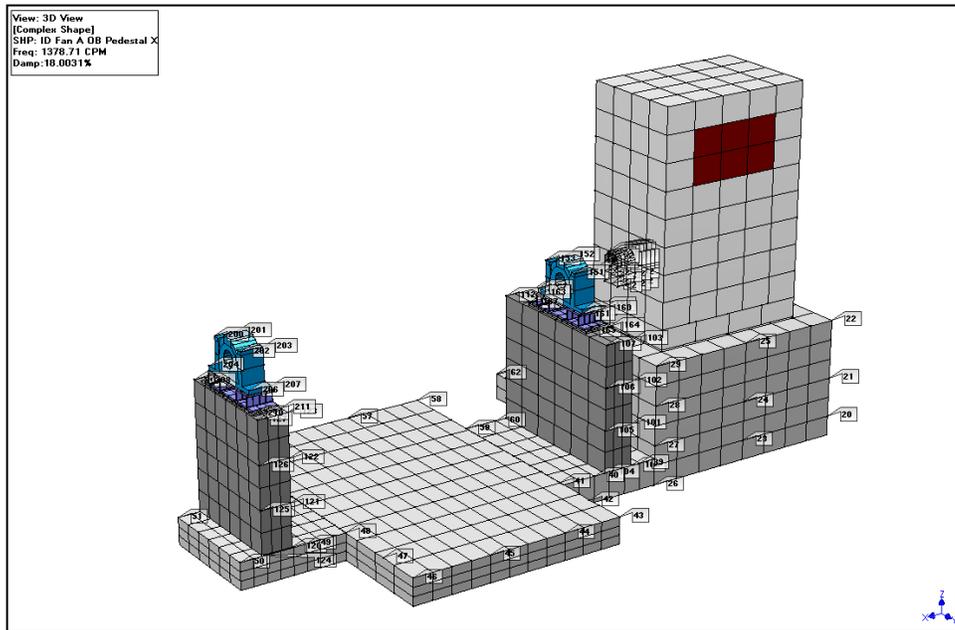
Figure 20. ME’scopeVES Model of ID Fan A.

ODS Analysis: The ODS Model was developed using ME’scopeVES [Ref 2]. The 3D computer model included the concrete foundation, concrete pedestals, motor, fan bearing housings, fabricated steel base supporting the fan bearing housings and soleplates, see **Figure 20**. ME’scopeVES provides drawing tools to develop very realistic models. Our models are typically drawn to scale as was this model.

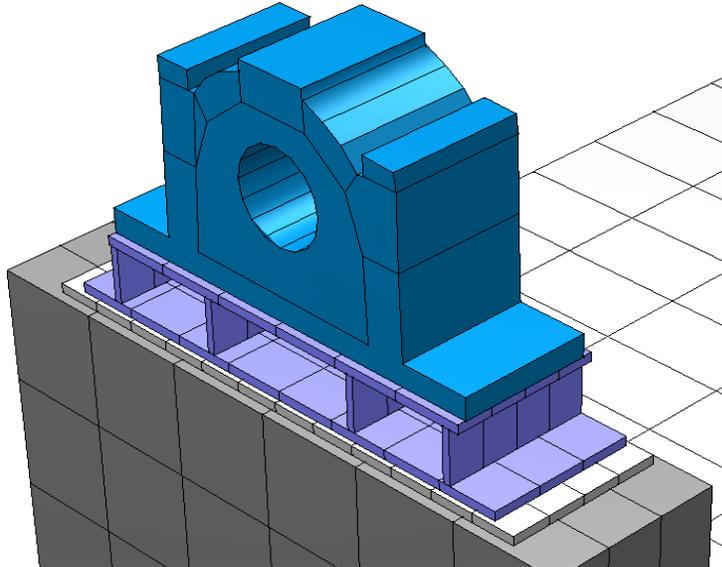
Figure 21. Detail of Fan Outboard Bearing, Fabricated Base, Soleplate and Concrete Pedestal.

could be displayed when animated. It is important to generate the model animation equations correctly in order to accurately show any relative motion between the bearing housings, fabricated bases, soleplates, pedestals, etc. A close up view of the outboard bearing and pedestal model is shown in **Figure 21**.

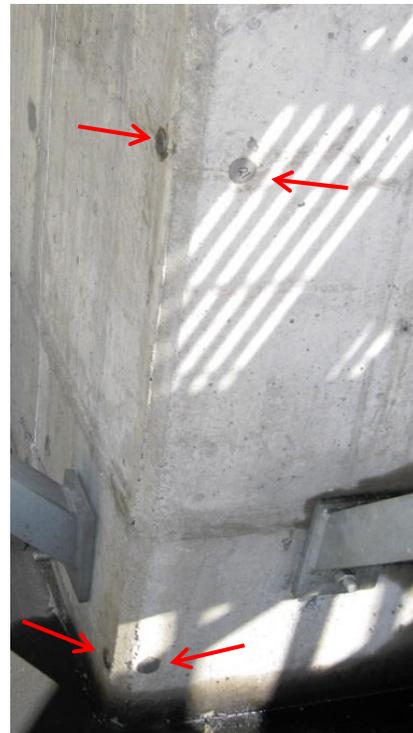
Figure 22. ID Fan A Outboard Pedestal With 410 SS Targets Epoxied.

Prior to measuring vibration data at the DOFs on the concrete, targets of 410 SS were epoxied at DOF coordinates measured using a steel tape. A recently introduced epoxy, Loctite Epoxy Metal/Concrete [Ref 1], with high strength bonding in 5 to 10 minutes was used. Approximately one hundred twenty five targets were epoxied to the concrete foundation and pedestals. ID Fan A outboard pedestal, East side is shown in **Figure 22** with epoxied targets.

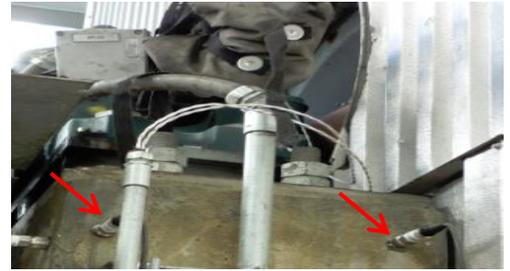
Figure 23. Flat Rare Earth Magnets Attached 500mV/g Low Frequency Accelerometers.

The ODS FRF Data was measured using a two channel CSI 2130 Analyzer and low frequency CTC AC133 500 mV/g accelerometers [Ref 5]. Flat rare earth magnets were used to attach the accelerometers to the 410 SS targets, as shown in **Figure 23**. Data was also measured on the motor, fan bearing housings, fabricated supports and soleplates. After uploading the data to the Emerson AMS software, the ODS FRF were exported to ME'scopeVES for generation of 3D structural animations.

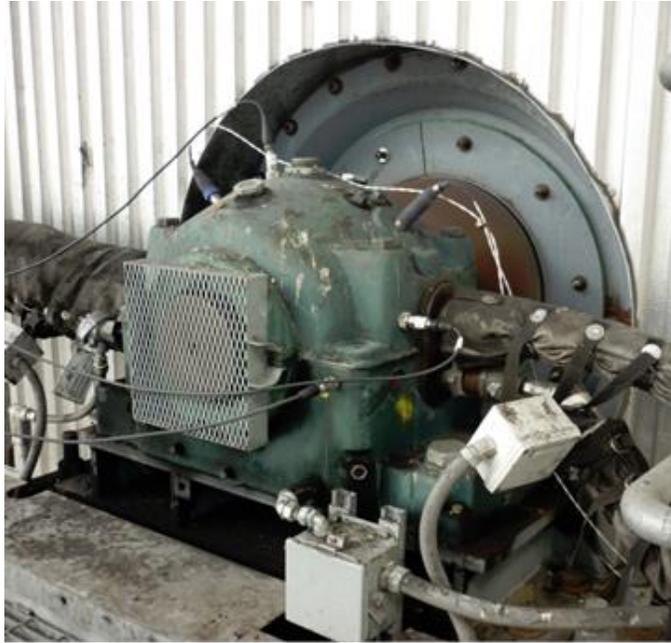
A photo of the Dodge Sleeve bearing and pedestal at the fan outboard position is shown **Figure 25**.

Figure 25: ID Fan A, Outboard Bearing Housing.

5. Insure that the Dodge Sleeve Bearing plunger bolts are torqued to $3600 \text{ in/lb}_f = 300 \text{ ft/lb}_f$ as stamped on the plunger stud.
 6. Remove the steel bracing connecting the ID Fan A & B outboard pedestals. Replace with individual bracing bolted to massive concrete pad per drawing, see **Figure 40**. Install the pedestal reinforcing plates per **Figure 39**.

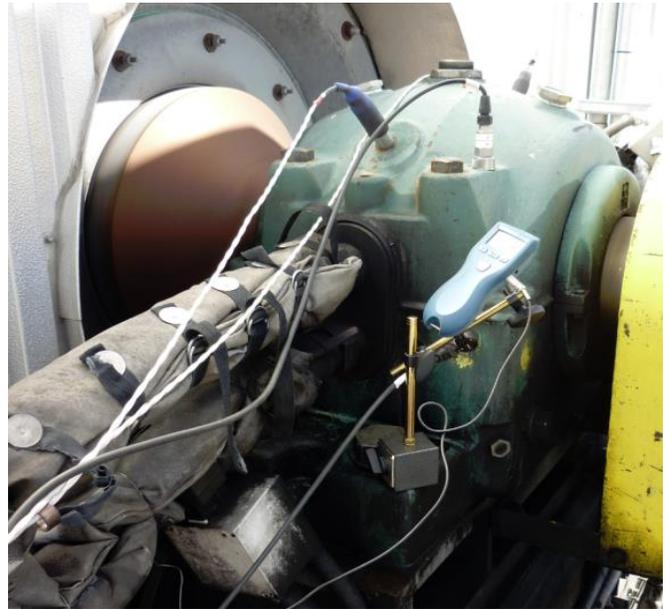
A photo of the inboard bearing housing is shown in **Figure 27**. The laser tachometer used to generate a once per revolution signal for our multi-channel data acquisition system is also shown. A piece of reflective tape had been attached to the shaft by a previous consultant and we were able to obtain a stable once per revolution trigger.

Figure 27. ID Fan A Inboard Bearing.

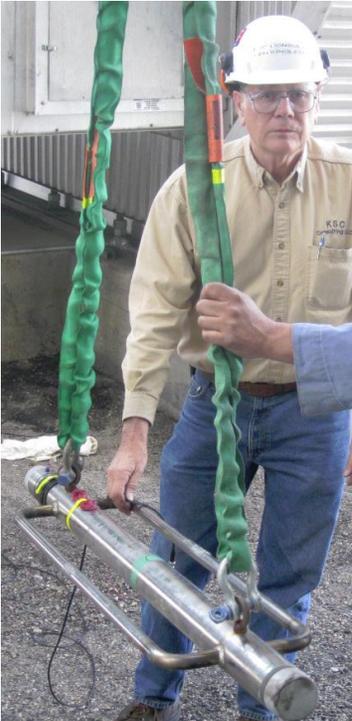
ID Fan A Outboard Bearing Pedestal Modal Test: The outboard bearing pedestal was modal tested using a 130 lb_f steel ram with a 50,000 lb_f force head stud mounted. A soft grey tip was attached to the force head to limit the excitation frequency band width from about 0 to 10,000 CPM. The ram was supported by Nylon slings and a motorized man lift, see **Figure 30 & 31**.

Figure 30. Author (Singleton) With Steel Ram Equipped With 50,000 lb_f Force Head Supported by Nylon Slings.

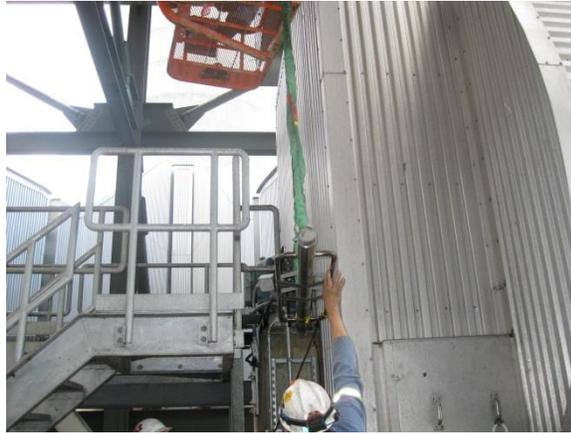
The pedestal modal test in the Y (side-to-side) direction was conducted by impacting with the force head at the top of the concrete pedestal at one corner. Impacts were on the left side (as viewed from the motor). Response was measured with low frequency CTC AC133 500 mV/g accelerometer magnetically attached to the 410 SS targets. Eight FRF were measured along both sides of the pedestal taking five averages for each DOF. The magnitude portion of the FRF driving point g/lb_f is shown in **Figure 32**. The cursors in the plot are located at the fan 1X and 2X frequencies. Curve fitting the data found the following:

- Natural frequency at 1432.84 CPM with 14.59 % of critical damping.
- Natural frequency at 2508.71 CPM with 3.20 % of critical damping.

Figure 31. ID Fan A, OB Bearing Pedestal. Modal Test in Y Direction (Side-to-Side).

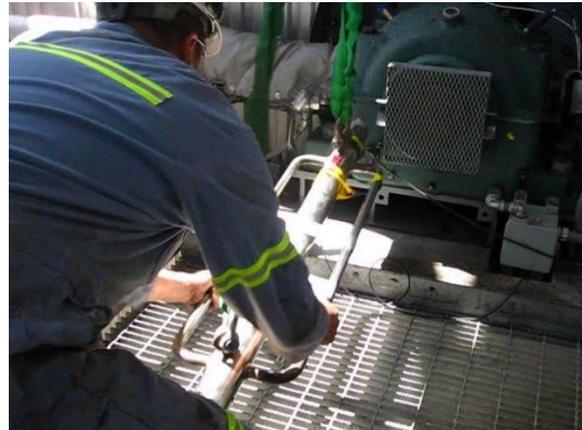
The modal test in the axial direction (X) was conducted by impacting the base of the bearing housing since the concrete pedestal was not accessible, see **Figure 34**. The driving point FRF is shown in **Figure 33**. The cursors are located at the fan's 1X and 2X run speed frequencies. Curve fitting the FRF data found the following:

Figure 34. ID Fan A, OB Bearing Pedestal Modal Test in X Direction (Axial). Impact Location was at base of the Bearing Housing since Concrete Pedestal Was Not Accessible.
