Stripped down report example – ODS Section for summary purposes only.

Background

The purpose of the testing was to diagnose the source of high vibration affecting wire connections below the generator on the current transformers (CTs) and Neutral Enclosure.

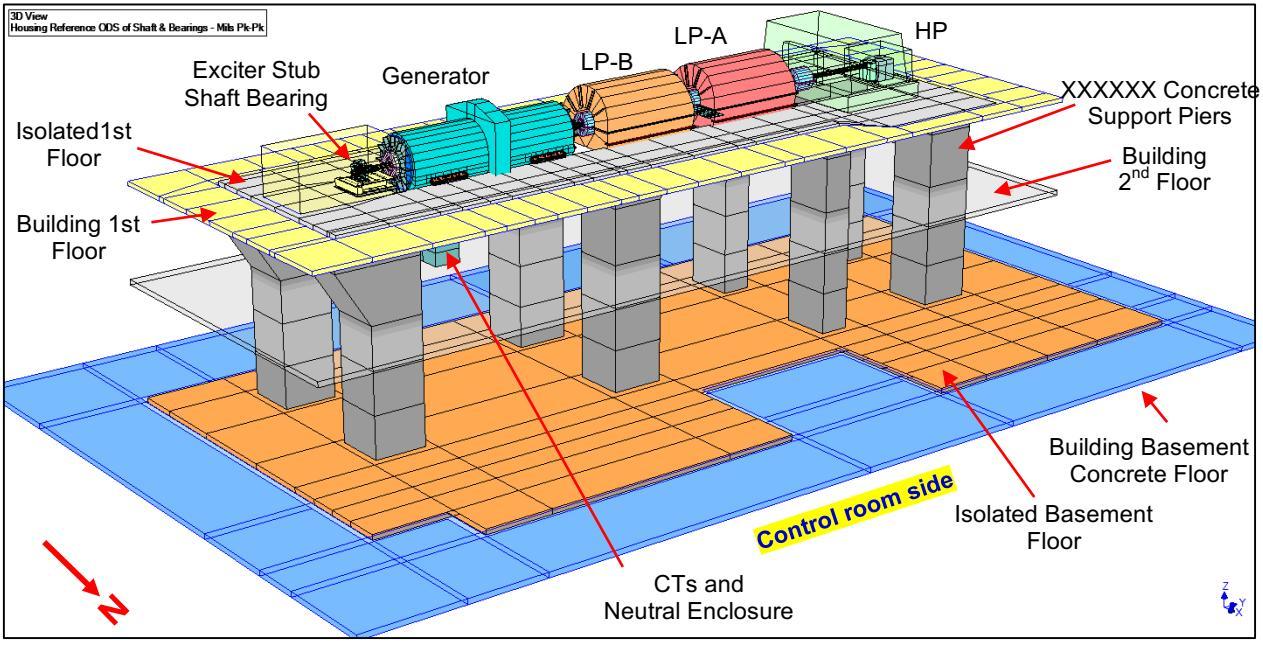
<u>Figure 7</u> XXXXXX TG, ODS Undeformed Structure Drawing (Complete Structure)

Figure 7 shows the undeformed structure drawing used for the ODS test.

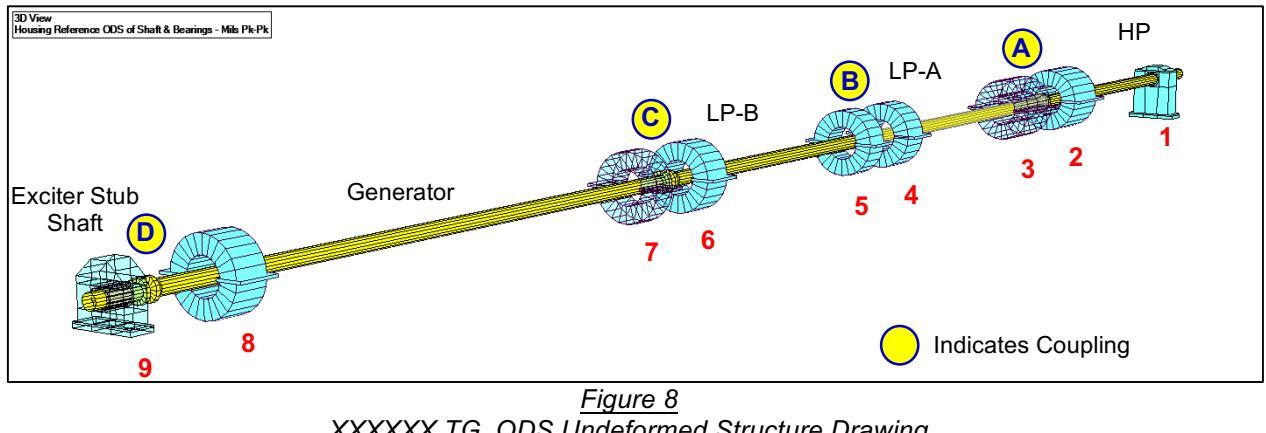
XXXXXX TG, ODS Undeformed Structure Drawing (Shafts, Bearings & Couplings)

Figure 8 names the bearings and couplings.

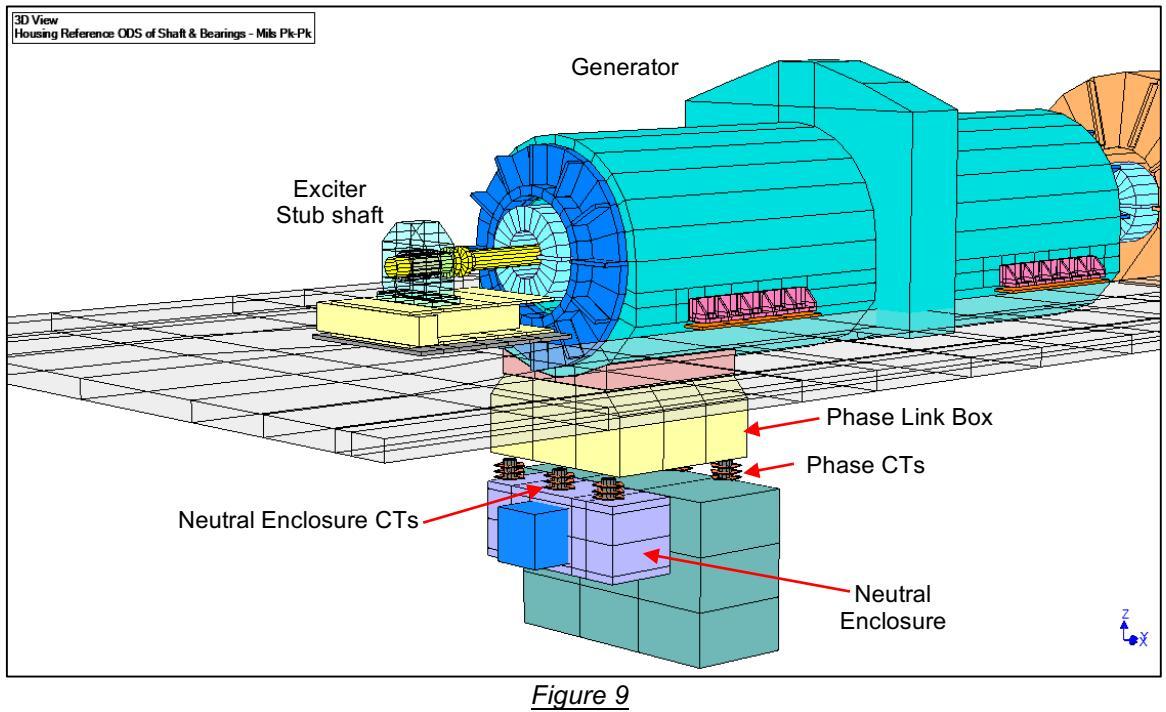
<u>Figure 9</u> XXXXXX TG, ODS Undeformed Structure Drawing (CTs and Neutral Enclosure Below the Generator)

Figure 9 identifies the components mounted to the bottom of the generator housing.

- 4.5 Generator housing vertical rocking motion is causing the transformers and neutral enclosure hanging from the bottom of the generator to vibrate with exaggerated response.
 - Displacement levels up to 35 mils pk-pk were measured on the CTs which explains the broken wire connections that have caused machine trips. Vibration on these components will subside once the generator housing is no longer rocking.
 - Up to 10 mils displacement was observed on the neutral enclosure.
 - Vibration on the large structure directly behind the neutral enclosure to the west was vibrating much less than the neutral enclosure because it is supported from below.

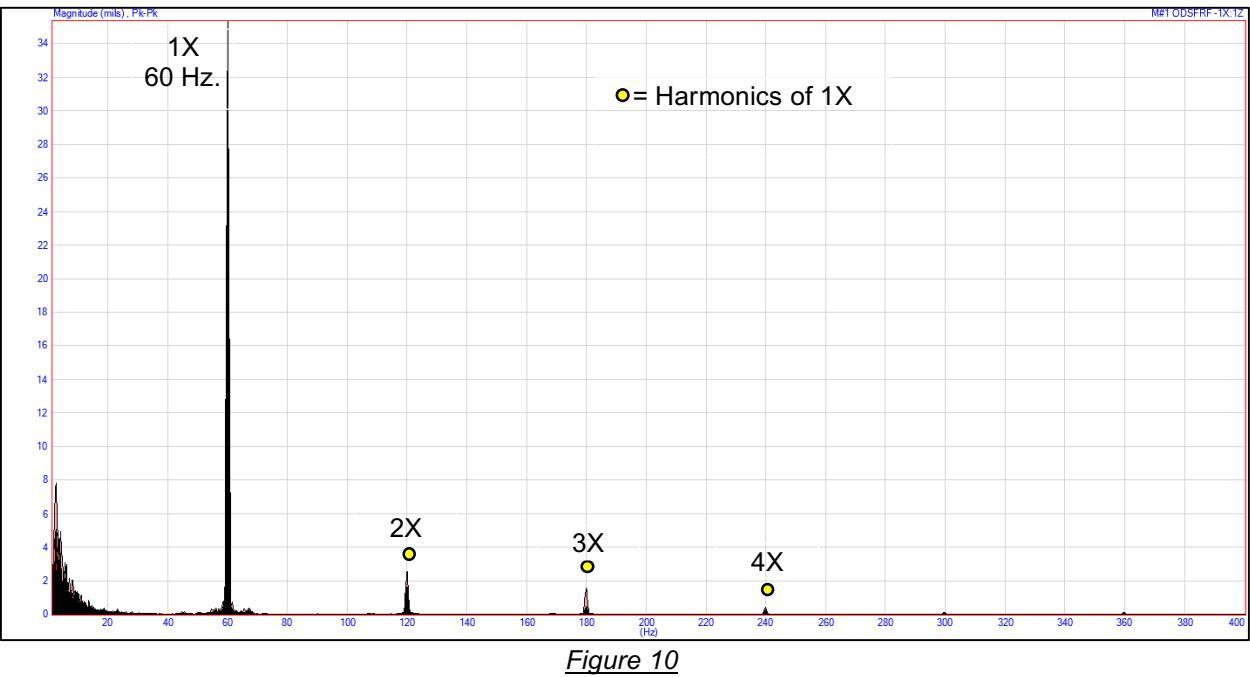
XXXXXX TG, Overlay of 2,428 ODS Frequency Response Functions

5.1 Figure 10 is an overlay of all 2,428 ODS Frequency Response Function measurements in displacement (mils pk-pk). The forcing frequencies of interest for the ODS were 1X and 2X shaft speed.

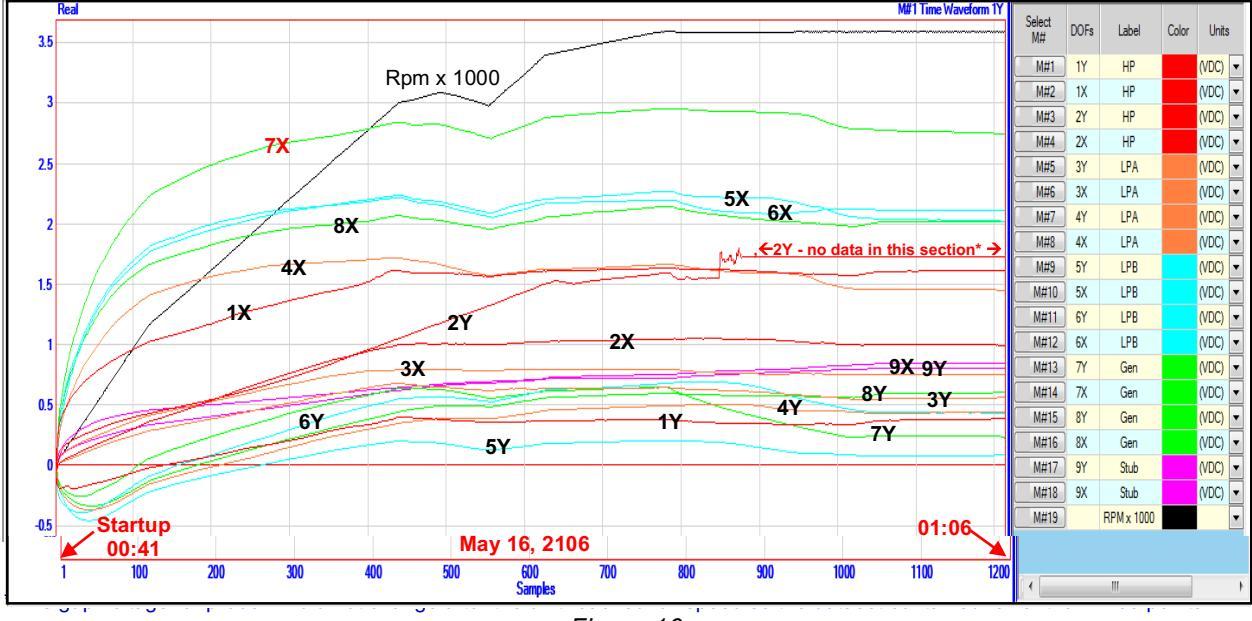
<u>Figure 16</u> XXXXXX TG, Radial Proximity Probe DC Gap Voltage Data Hot Roll-up, XX-XX-20XX - this data was used for DC Shaft Position ODS

A Shaft Position Operational Deflection Shape (SP-ODS) was completed using radial Proximity Probe DC (gap) voltage data. The SP-ODS identifies dynamic change in shaft position after rotation begins. The SP-ODS does not take into account static shaft misalignment or alignment compensation for thermal growth.

The dataset used for the SP-ODS contains 1200 DC gap voltage points per channel extracted from the Bently System 1 from a hot roll-up on XXXXX, 20XX after a trip caused by a broken CT lug. This startup was prior to 4X Diagnostics' testing. The dataset includes run-up to full speed, heat up and applied load. Trend Plots of the DC data used for the SP-ODS test are shown in Figure 16. Trace data prior to roll-up has been normalized to zero.
